Mosman
COUNCIL

ASSET MANAGEMENT Marine Structures

1 Executive Summary

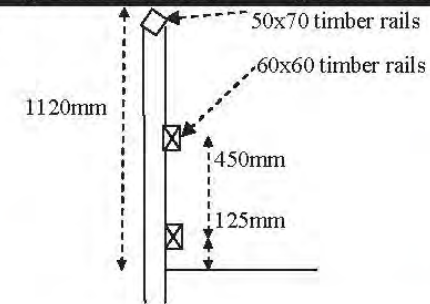
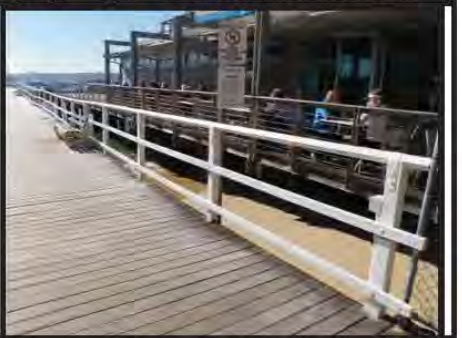
Element 1 Timber handrails on jetty (Typical)

Element Material	Painted Timber	Condition Category:	2 – Corroded connections
------------------	----------------	---------------------	--------------------------

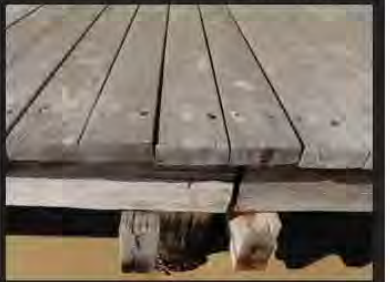
Element 2 Timber Decking

Element Material	Timber	Condition Category:	2 – Some loose coach screws
------------------	--------	---------------------	-----------------------------

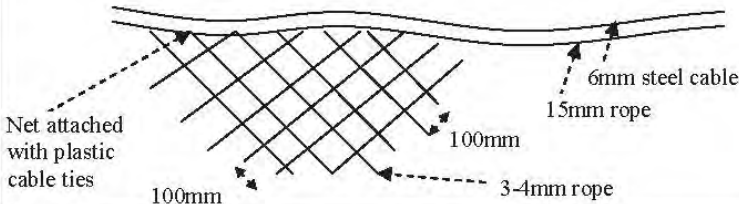
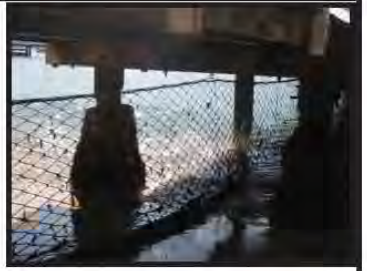
Element 3 Shark netting

Element Material	Rope	Condition Category:	2
------------------	------	---------------------	---

Element Condition. Refer to underwater inspection notes for net condition underwater.

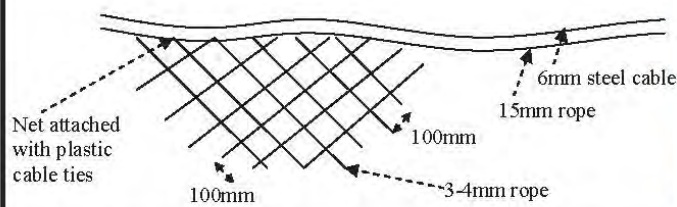
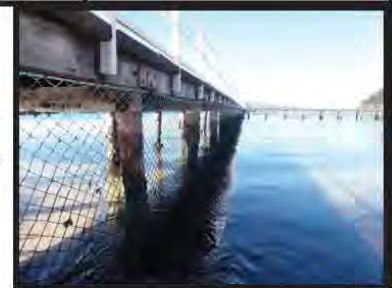
Element 1 - Shark netting around jetty

Element Material	Rope	Condition Category:	2
------------------	------	---------------------	---

Element Condition – Refer to underwater inspection notes for net condition underwater.

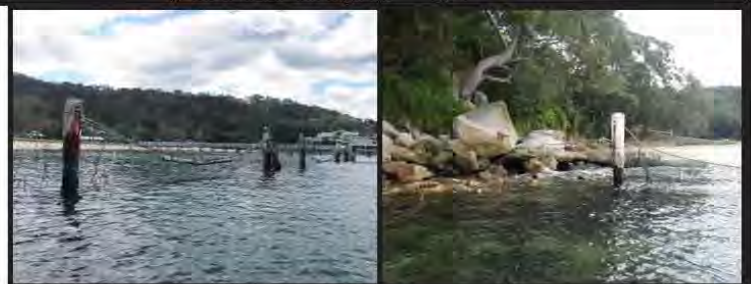
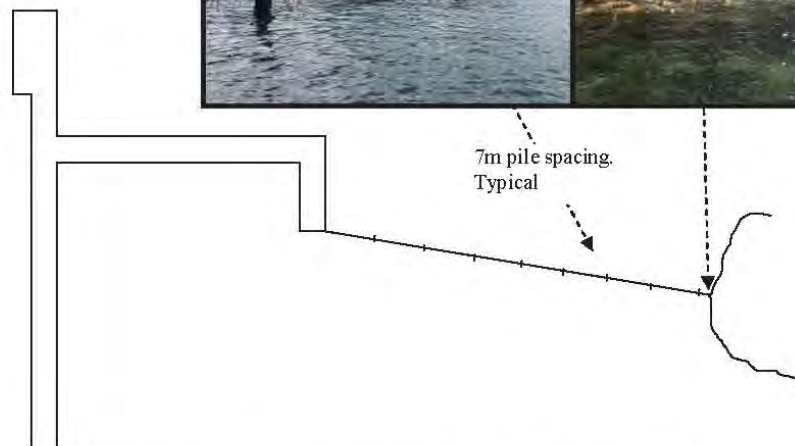
Element 2 Shark net extending from jetty

Element Material	Rope	Condition Category:	2
------------------	------	---------------------	---

Refer to detailed underwater inspection notes for condition of shark net and piles.

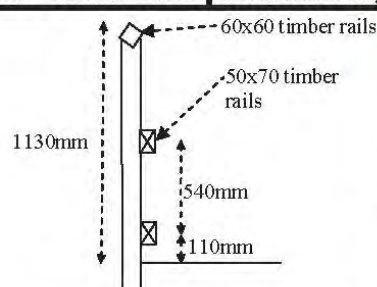
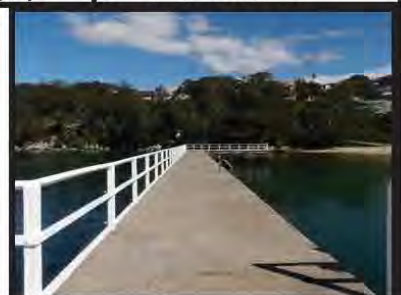
Element 3 Jetty Handrails (Typical)

Element Material	Timber - Painted White	Condition Category:	1 – Good condition
------------------	------------------------	---------------------	--------------------

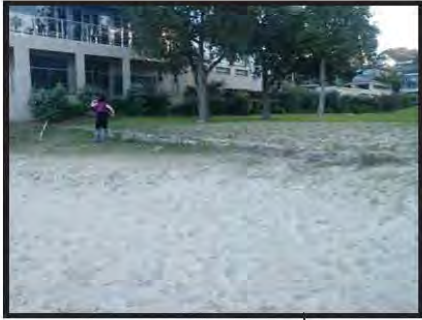
Sandstone seawall. Condition 1.

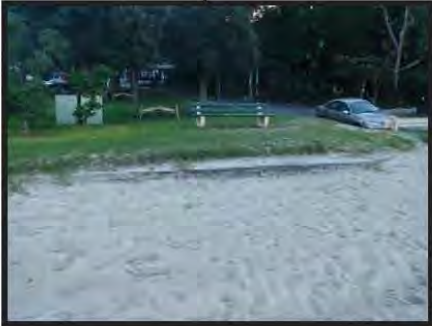
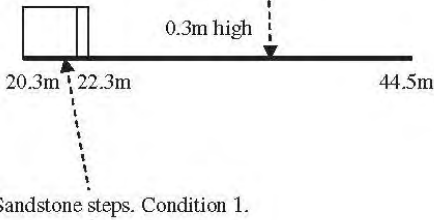
Sandstone steps. Condition 1.

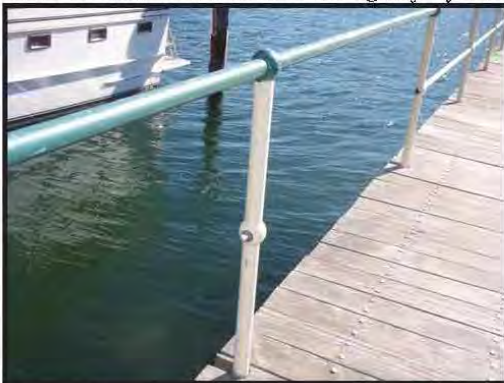
Three sections of central rail missing in jetty handrail to be replaced.

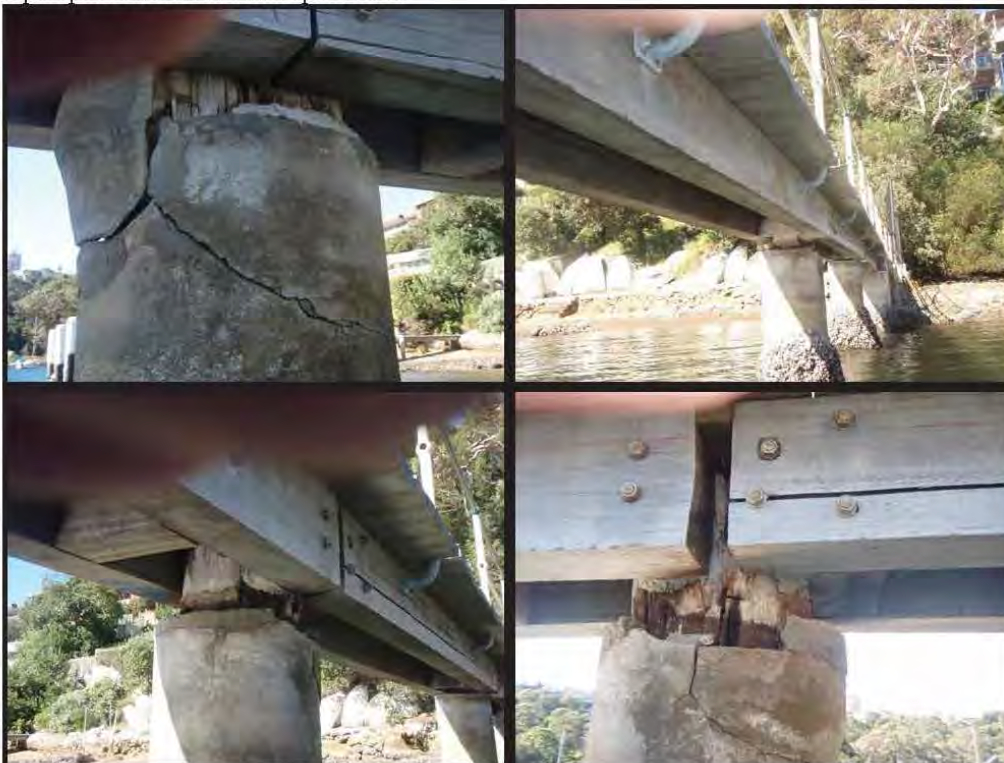
Element 3

Element Type	Jetty piles	Element Material	Timber (Fibre reinforced pipe encased)
Element Dimensions		Condition Category:	Main piles – 3, End stair piles - 4

4/Main jetty supporting piles - timber encased with fibre reinforced pipe. Fibre reinforced pipe at the top of piles has cracked and spalled off.

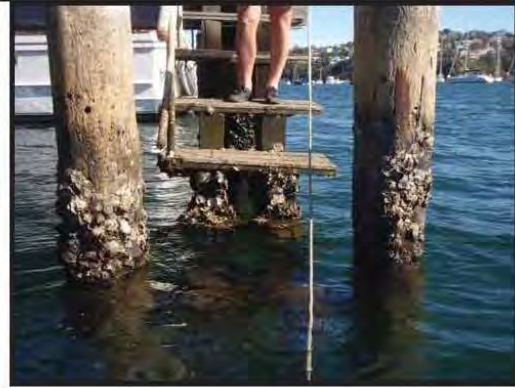
2/End piles located at base of stairs at end of jetty. Timber piles, with severe degradation and insect attack. Recommend replacement.

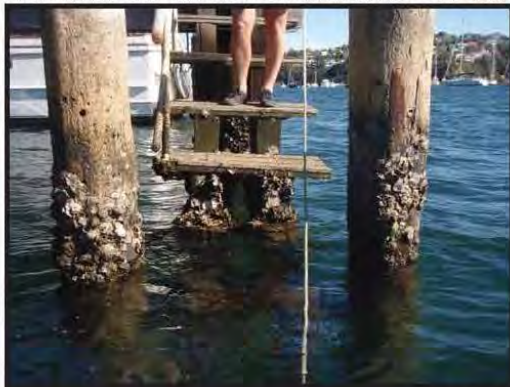
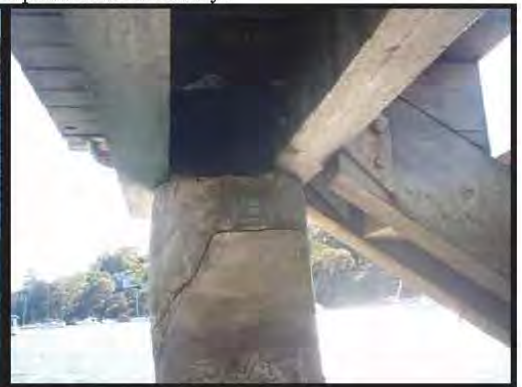
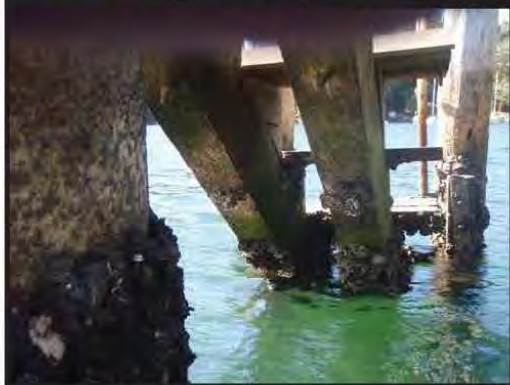
Element 4 – IS1

Main Structure Elements	Condition Grade	Comment
Steel handrails	2	Missing central railing
Timber decking	1	Very Good condition
Timber stairs	5	Complete loss of connection to supporting timber piles. Close jetty and repair.
Timber girders	2	Some timber distortion at connections
Piles	3 & 4	Main piles condition 3 due to sleeve cracking at the top of pile. 2 end of stair piles are condition 4 due to worm attack.

Element Type	Stairs at end of jetty	Element Material	Timber
Element Dimensions	Refer to DWG's	Condition Category: 5 – Replacement required

The jetty stairs have detached from the supporting piles at the base of the stairs due to severe degradation to the timber members. The bottom step has severe loss of section. The stairs currently cantilever off the jetty, and the bending load is carried by the stair bearer connections and the steel hand rail which is over loading and in a potentially unsafe condition. We recommend the stairs be closed from service and replaced immediately.

- Replacement of corroded steel connectors (Bolts, screws and splice plates etc)
- Replacement of piles with a section loss 50% or greater.
- Replacement of timber stairs on the Inkerman Street jetty (severely deteriorated).
- Replace signage when out dated

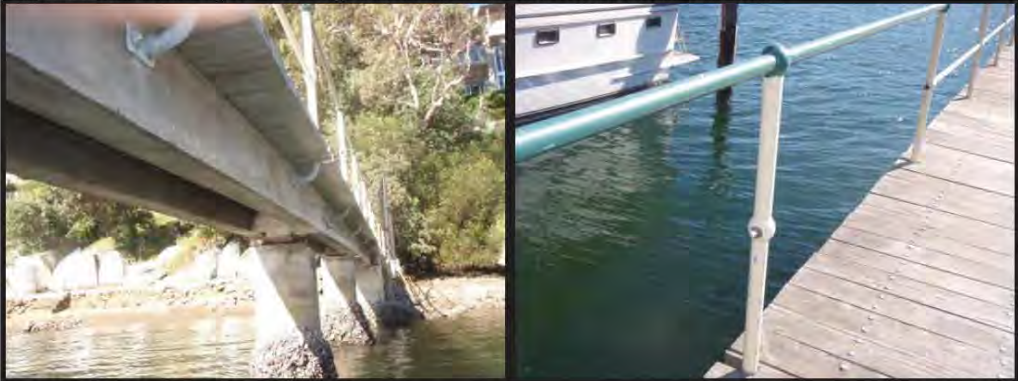
Element 5 – IS1			
Element Type	Jetty Deck	Element Material	Timber
Element Dimensions	1m x 18m	Condition Category:	1 – Good condition
Element Description:			
Decking – 1000x150x50mm Timber planks connect to timber bearers by 4/SS coach screws per plank (16mm head size). Decking supported by twin timber bearers – 300x150x4.5m long. Timber bearers seated into top of timber piles, connected with twin SS 16mm bolts.

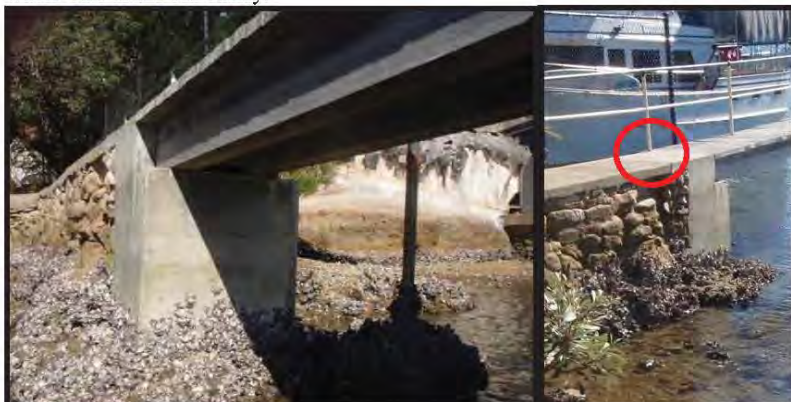
Element 6			
Element Type	Jetty Abutment	Element Material	Concrete
Element Dimensions	1m wide, 1.4m high, 1m deep, 0.3m bearing shelf.	Condition Category:	1 – good condition

Element Description:
 This concrete abutment is in good condition, except for cracking in the concrete where the handrail post is embedded into the concrete, which requires monitoring. This detail does not allow water to drain out of the handrail post void in the concrete and corrosion will further develop. Eventually this corner of concrete, will require cutting out and the handrail post should be bolted into the concrete so water can drain off easily.

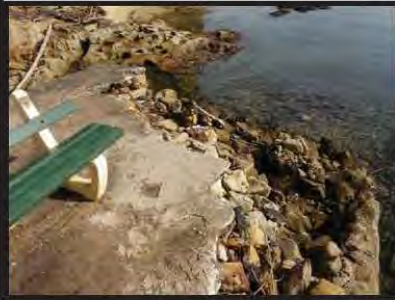
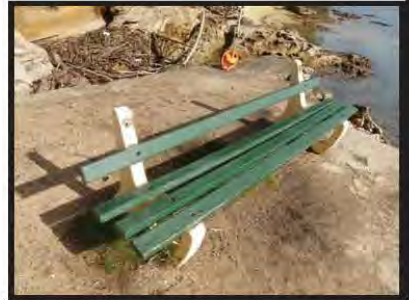
Collapsed seawall. Condon 5.
Repair seawall.

- Replacement of collapsed sections of seawalls
- 5m section of collapsed sea wall to be replaced at Middle Harbour Seawall – RW41
- 4m section of collapsed seawall to be replaced at Clem Morath Pool – EB1
- Replace signage when out dated
- Replacement of sandstone blocks with greater than 30% loss of section.
