## Safety Alert 191209-1A (Update)

14 February 2020

### Serious burns sustained while operating high voltage switchgear

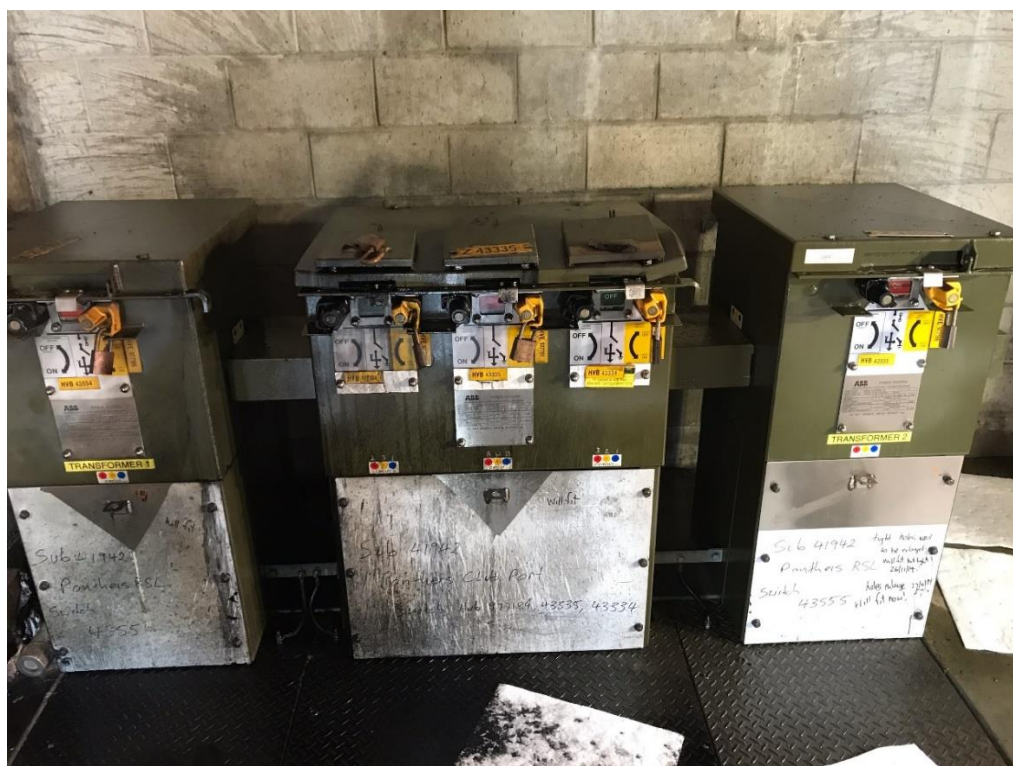
Two workers sustained serious burn injuries while working on electrical network assets.<sup>1</sup> Information provided by the network operator indicates that a **failure occurred within an oil-filled metal clad switch (the Switch) while operating work was being performed.**

Image taken at site by a SafeWork NSW inspector after the accident

The Switch was found in the open position with evidence of arcing on the tips of both its moving and stationary contacts. The Switch was assessed and tested and found to be performing as designed.

The preliminary review of the incident indicated that at the time the circuit breaker auto-reclosed (onto the faulted underground section), the Switch was being manually opened by the injured worker and was therefore attempting to interrupt the fault current. We note that the Switch is not designed to be opened to interrupt fault current.<sup>2</sup>

The preliminary review by the network operator indicates that the ABB SD3+SDAF Switch<sup>3</sup> was not the cause of failure and that external factors resulted in the failure.

- All distribution High Voltage (HV) oil-filled switchgear to be de-energised prior to local operation, with the HV conductors feeding the switchgear remotely isolated.
- Re-energisation shall only be completed via a remote switch, with the substation that the switch is housed in vacated and secured to prevent access during these operating activities.
- The operating restriction applies to all planned and unplanned work tasks.
- There are no additional restrictions regarding general access to substations containing HV oil-filled switchgear and remote operating work may continue as per normal practice.

- ▼ disabling auto-reclosing during fault finding and network restoration switching activities
- ▼ remote energised switching of older manually operated switchgear using permanent or temporary actuators
- ▼ local de-energised switching of oil-filled metal clad distribution switchgear
- ▼ use of suitable arc rated clothing, face shield and PPE when performing local energised switching
- ▼ risk-based replacement of older switchgear with modern oil-free switchgear compliant with internal arc containment standards.
