Notification of fatal incident involving a low power line

12 November 2024

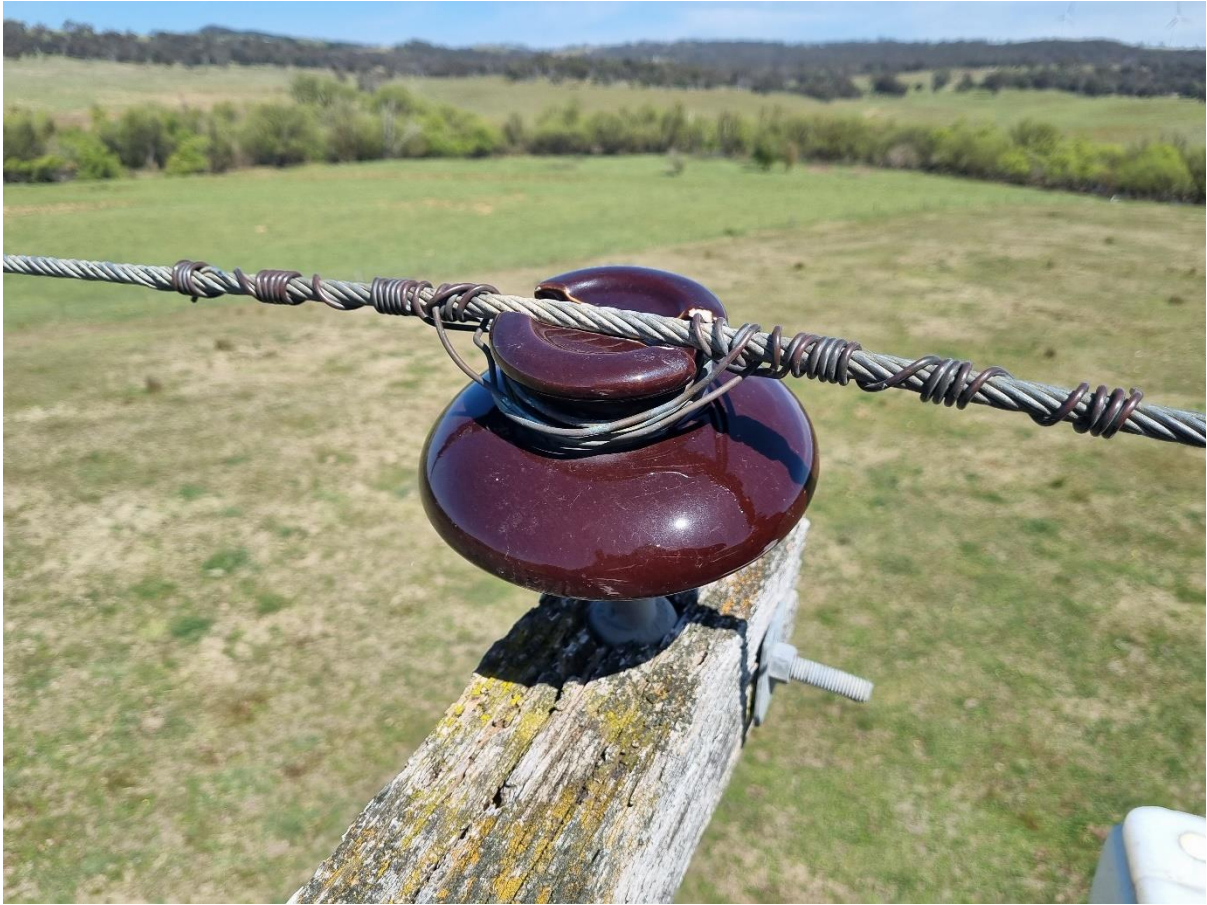
Above – Other conductor on the pole, shown tied onto a pin insulator on a pole mounted crossarm.

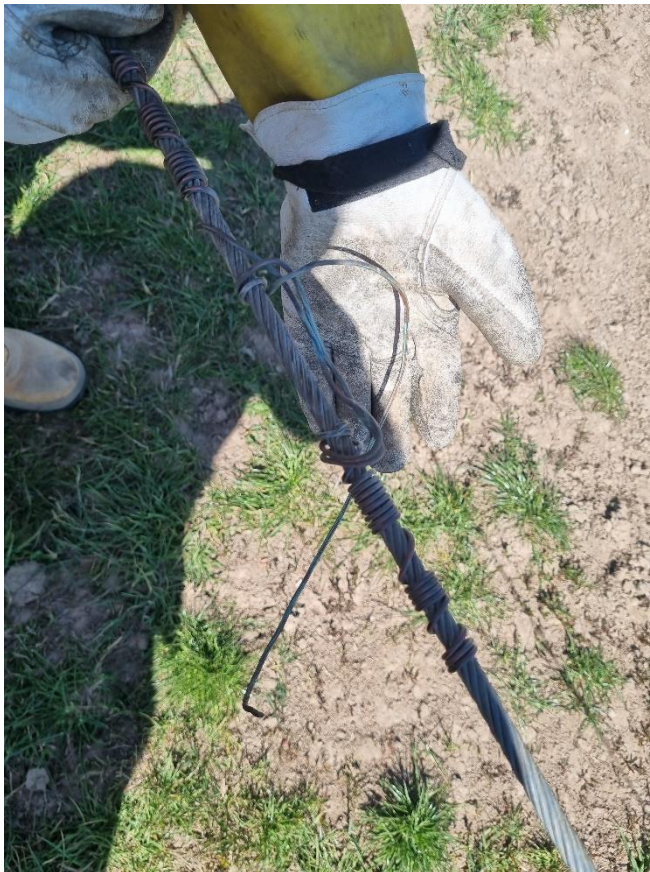
On 18 September 2024, a member of the public was riding a motorbike on private property when he is suspected to have struck a live 11kV conductor and sustained fatal injuries. A tie wire, which tied the 11kV conductor onto the pin insulator on a pole mounted crossarm, had failed. This allowed the conductor to fall from the pole, where it remained suspended close to the ground. Please refer to the photos on page 2 for further information.

Left – Conductor involved, shown hanging off the pole near ground level and with the broken tie wire still on attached.

- clearly documented processes to adequately inspect assets in public areas, and to identify conditions that may lead to asset failure or pose a safety risk
- training and competency assessment of asset inspectors
- processes to ensure that any defects are identified, prioritised and rectified to ensure that safety risks from the network are as low as reasonably practicable.
