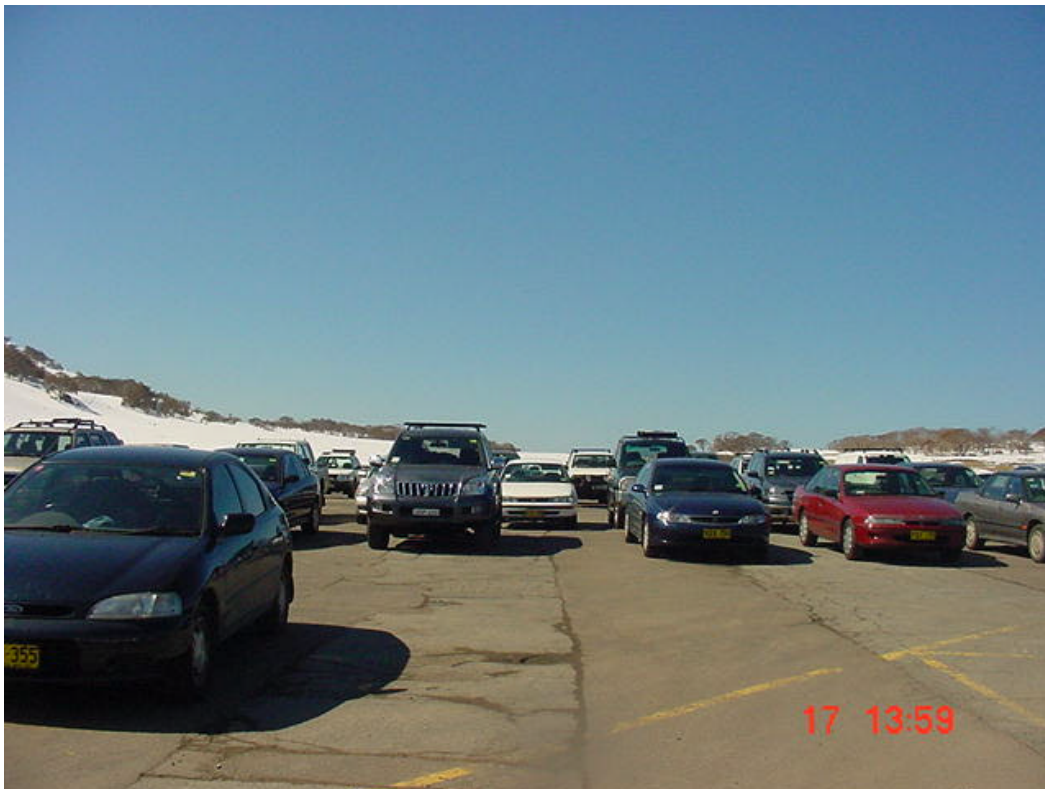
PHOTOGRAPH No.16. Example of scattered car parking (poor surface condition)

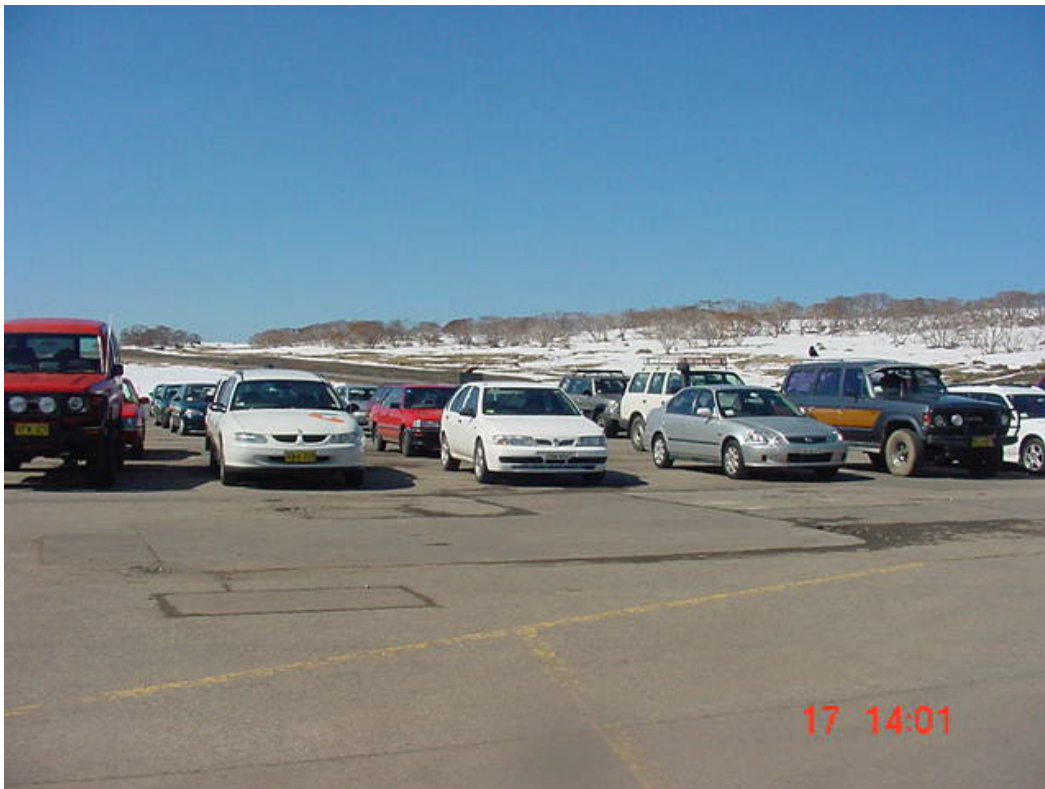
PHOTOGRAPH No.18. Another view of scattered car parking (poor surface condition)
