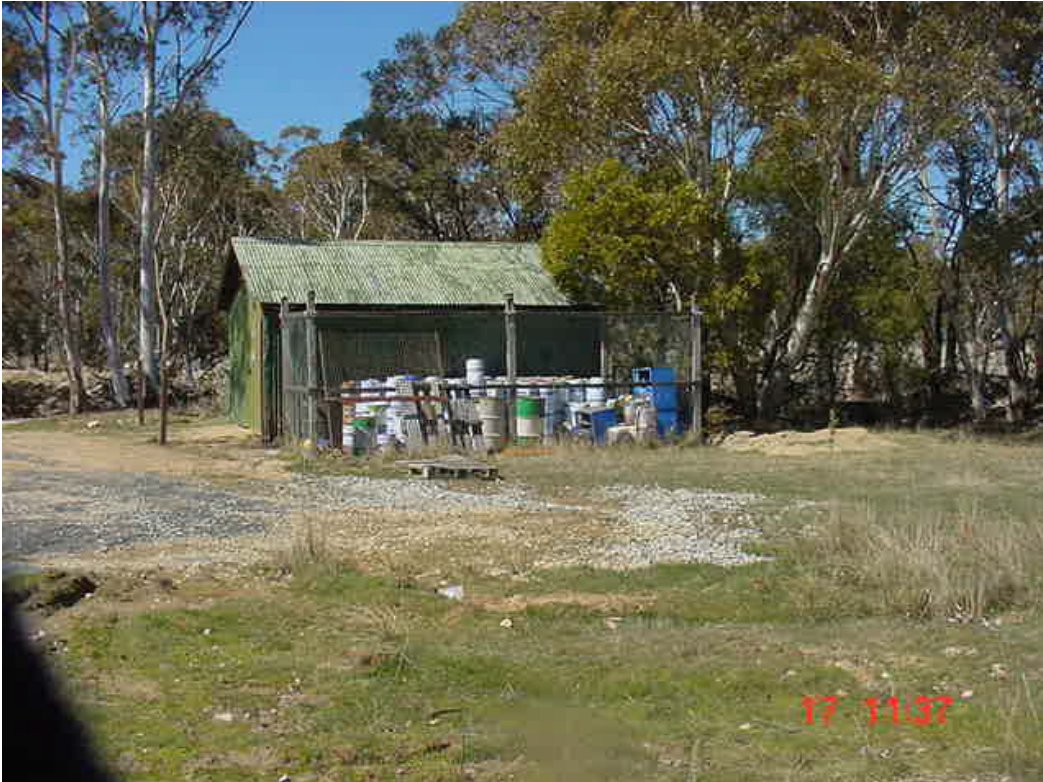
PHOTOGRAPH No.37. Cooking oils can storage.

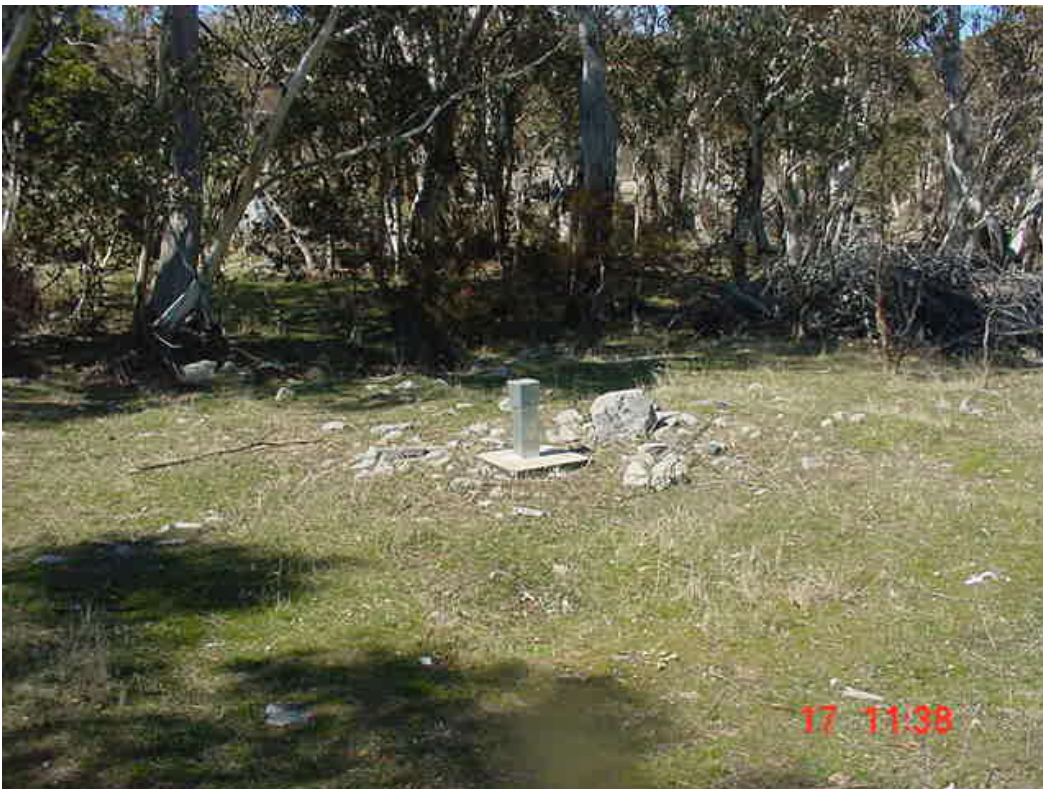
PHOTOGRAPH No.38. Groundwater monitoring around current Landfill

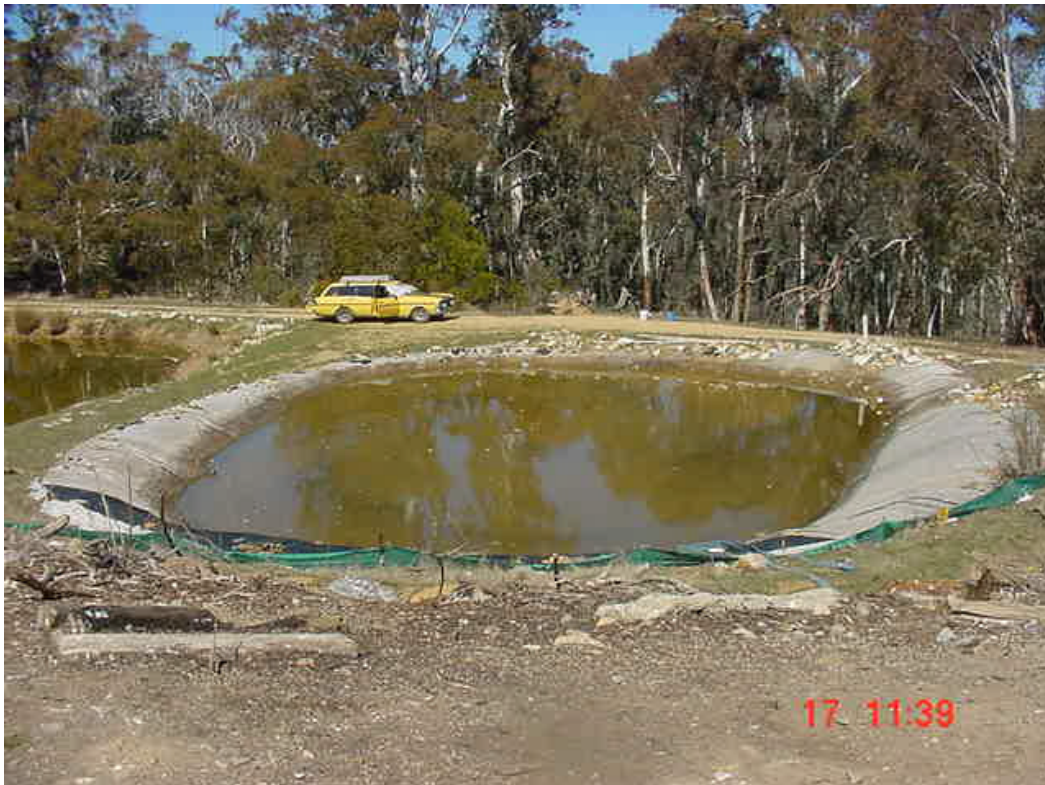
PHOTOGRAPH No.39. Leachate primary settling pond (plastic lined)

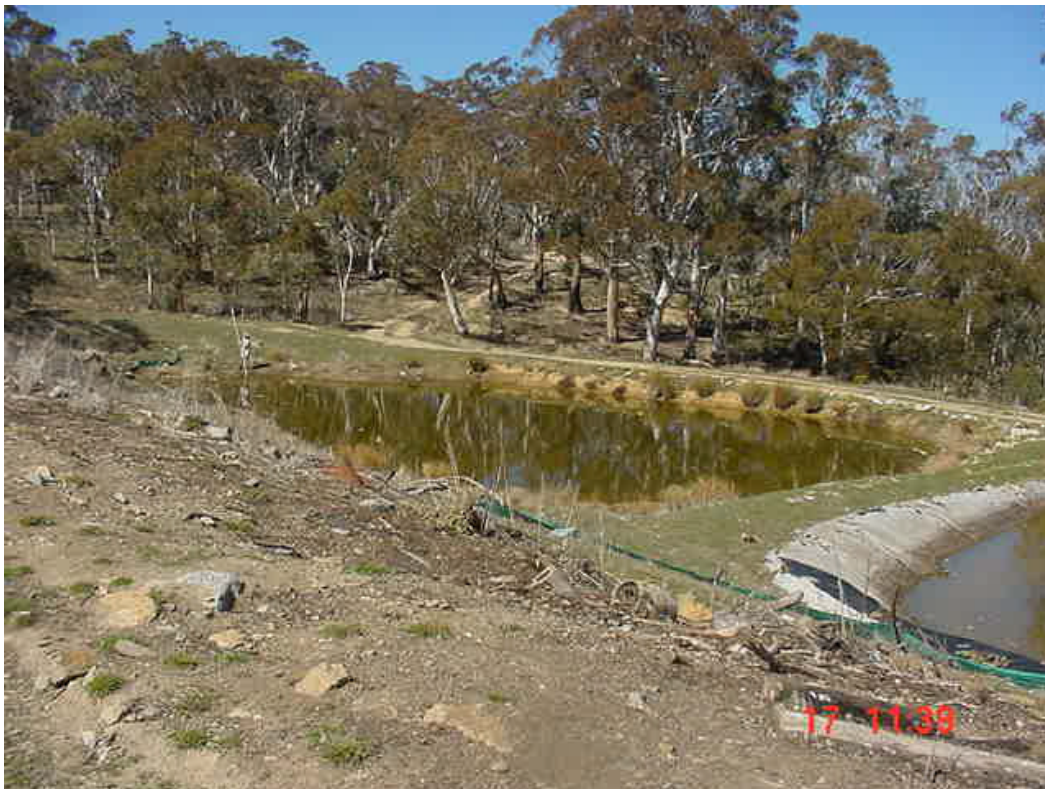
PHOTOGRAPH No.40. Secondary settling pond (unlined)

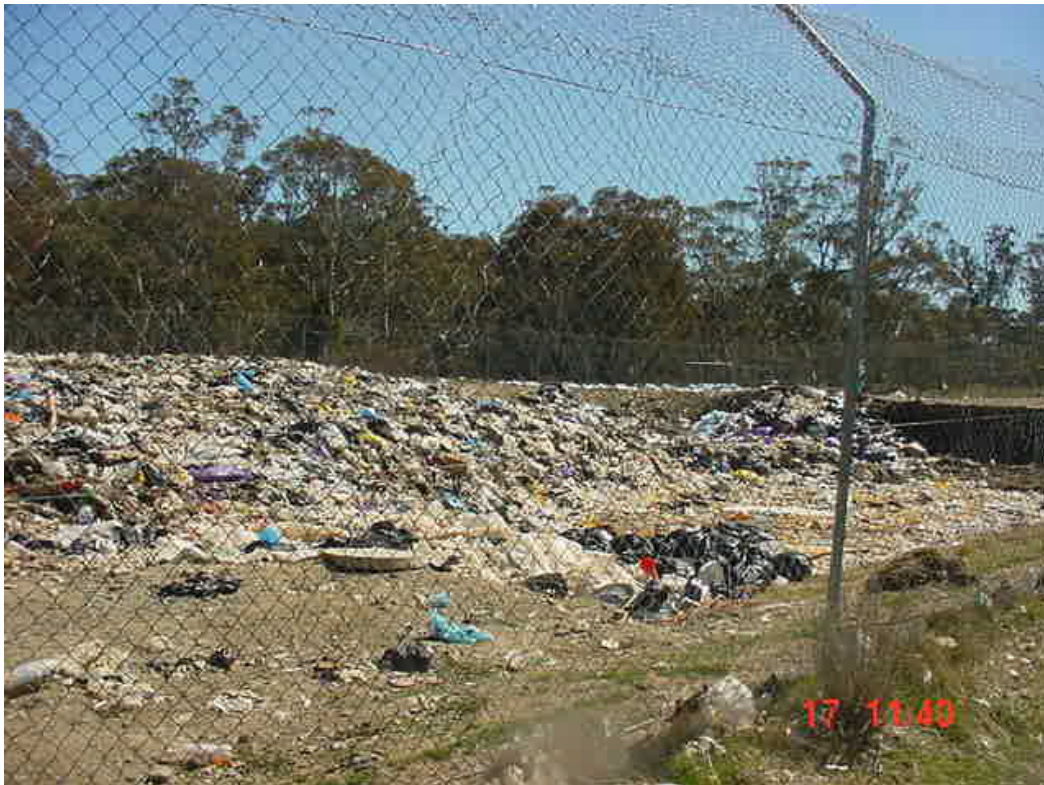
PHOTOGRAPH No.41. Current landfill – no evidence of daily soil cover

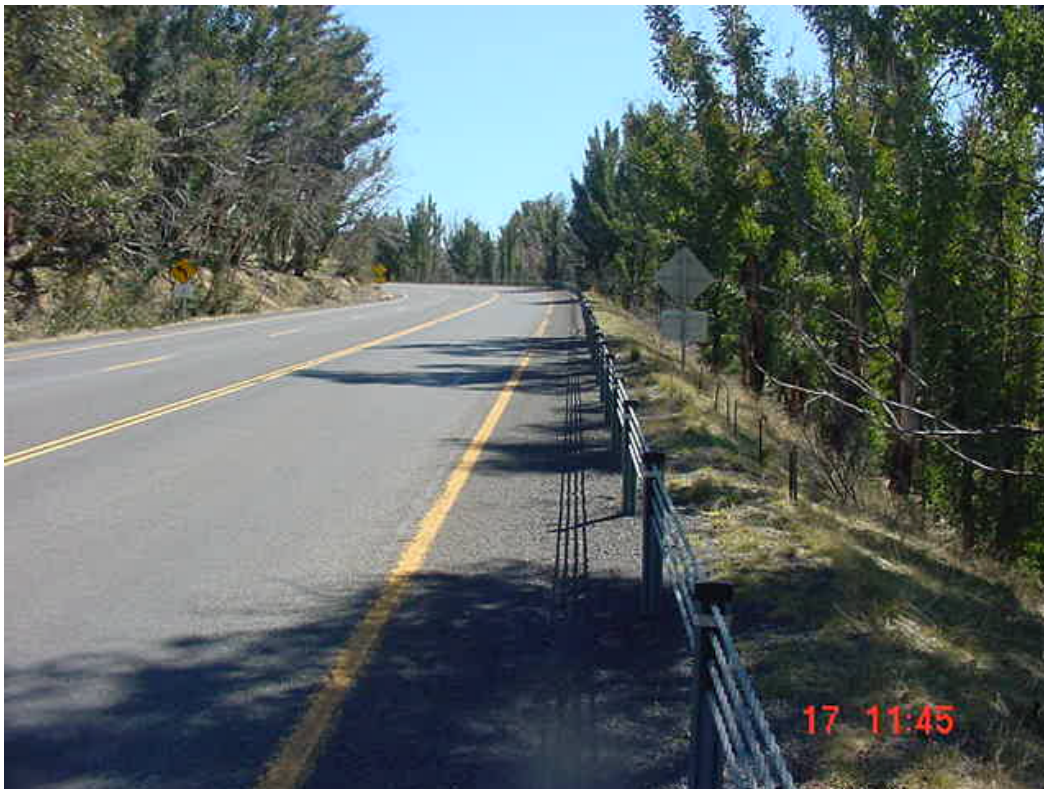
PHOTOGRAPH No.42. Kosciuszko Road (good section – sealed to edge & fenced.
