## Safety Alert 190409-1C Update

22 July 2019

### Fatal electric shock during live low voltage pole changeover

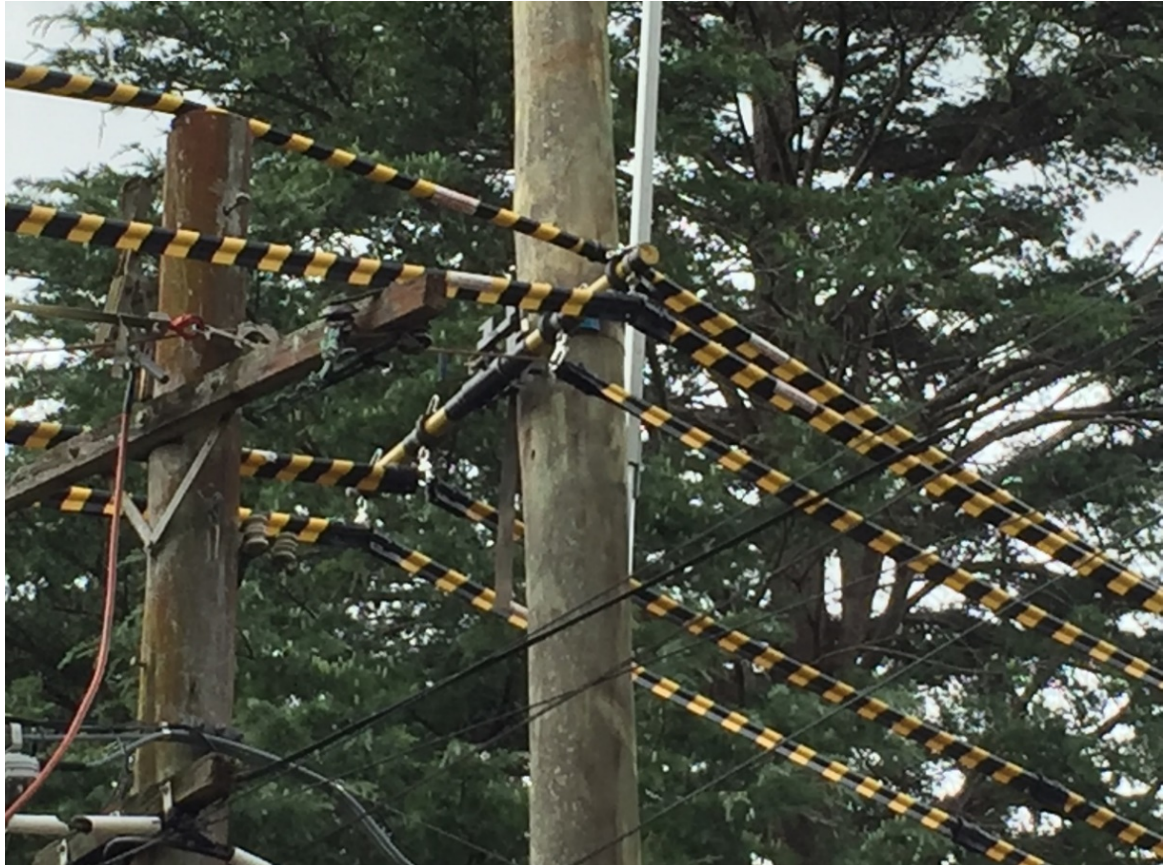
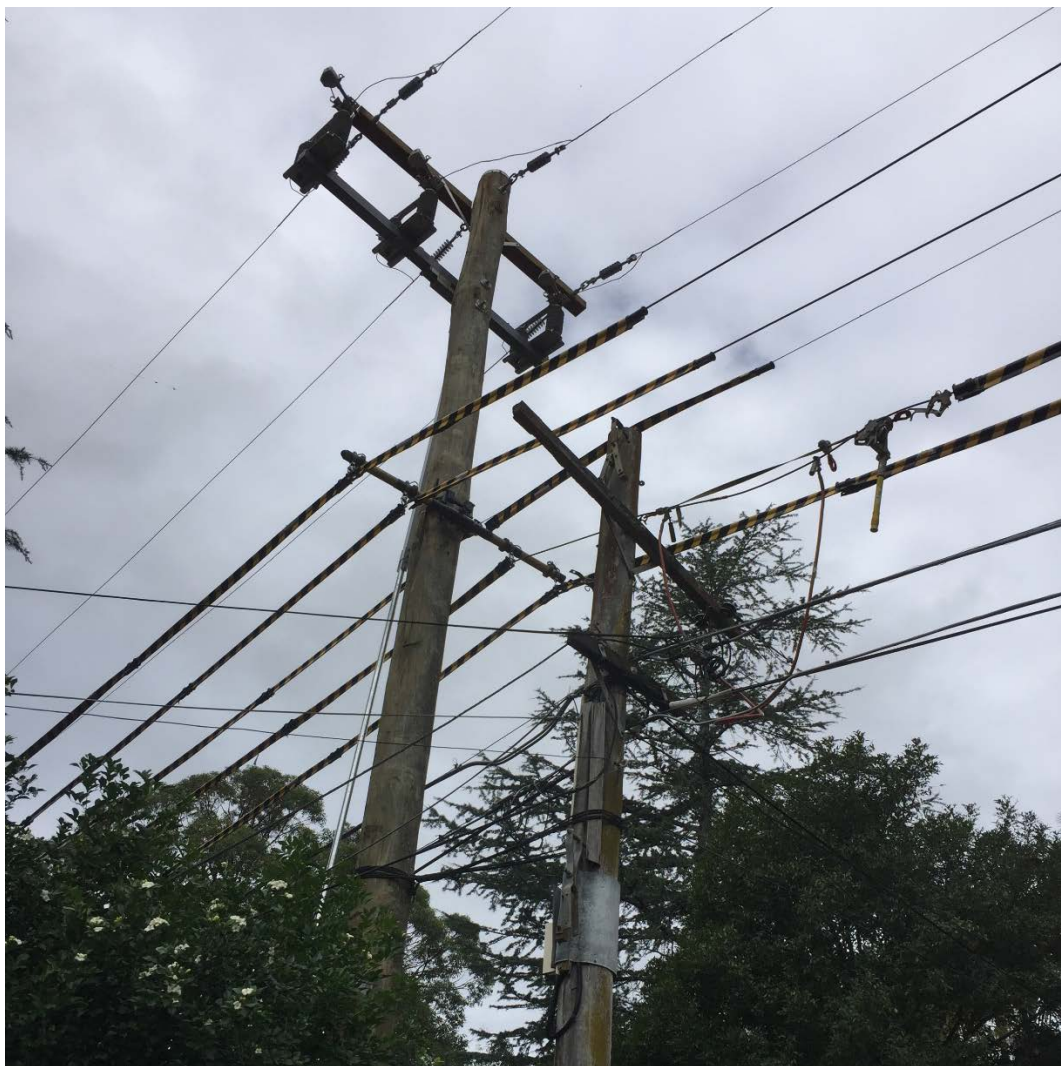
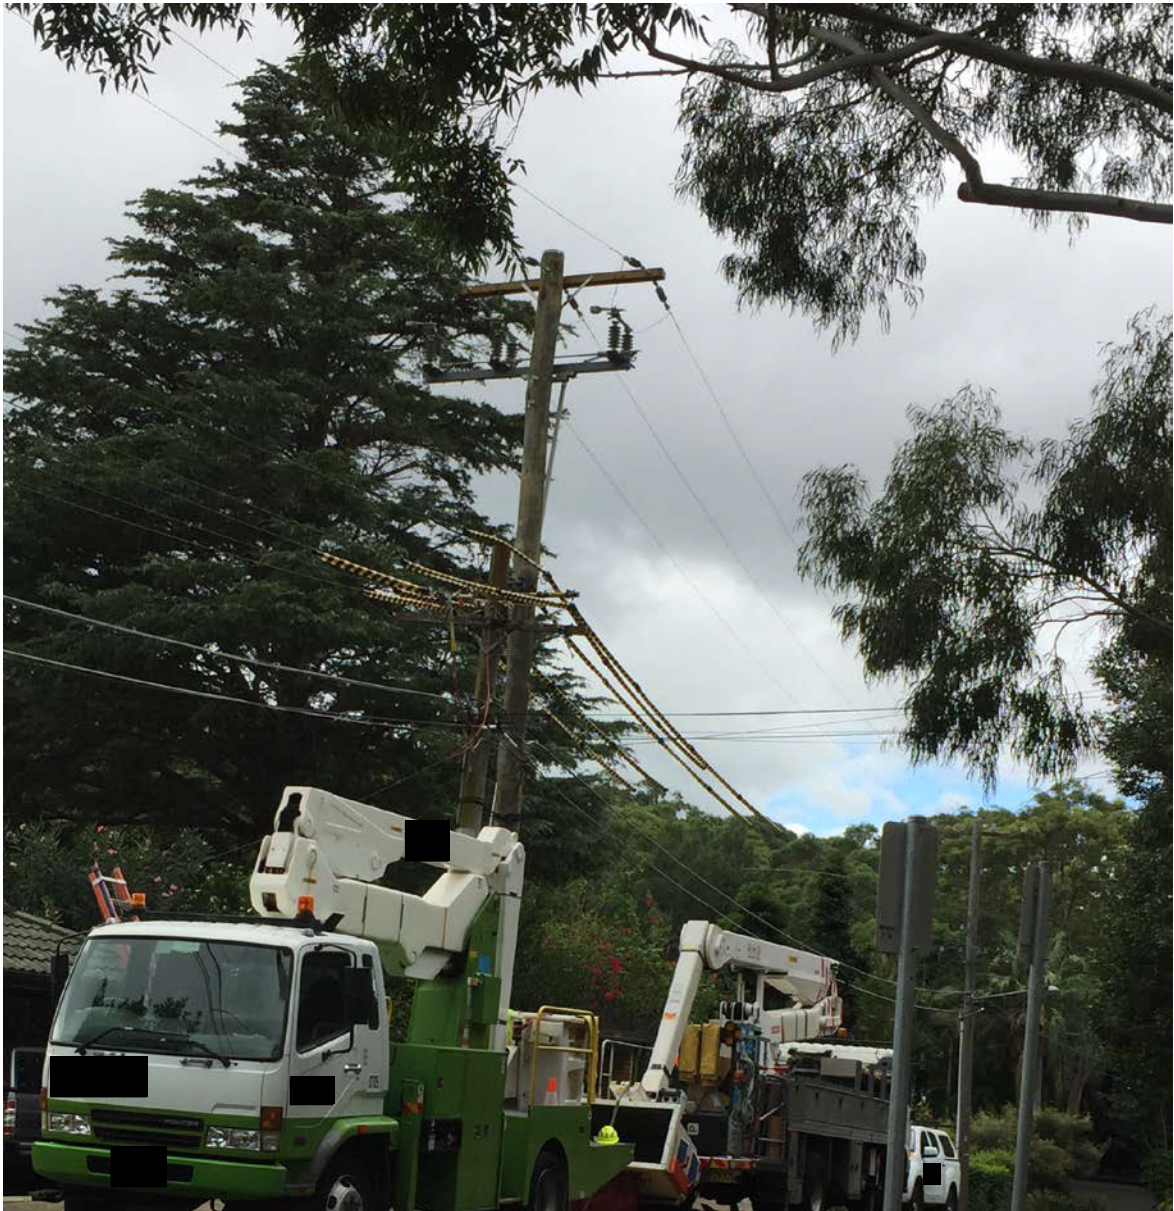
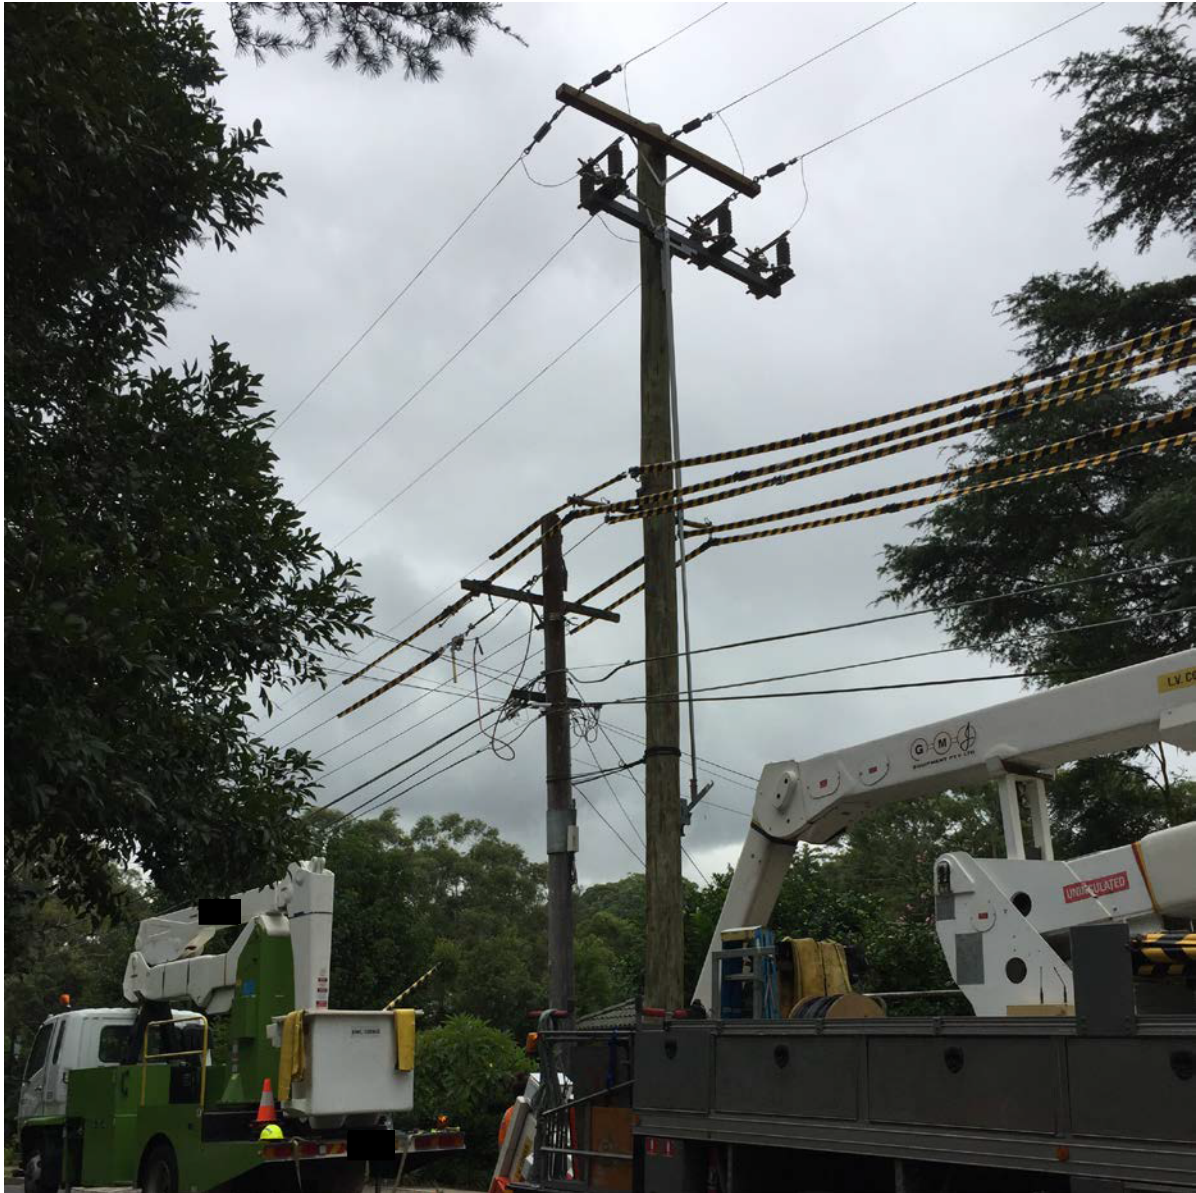
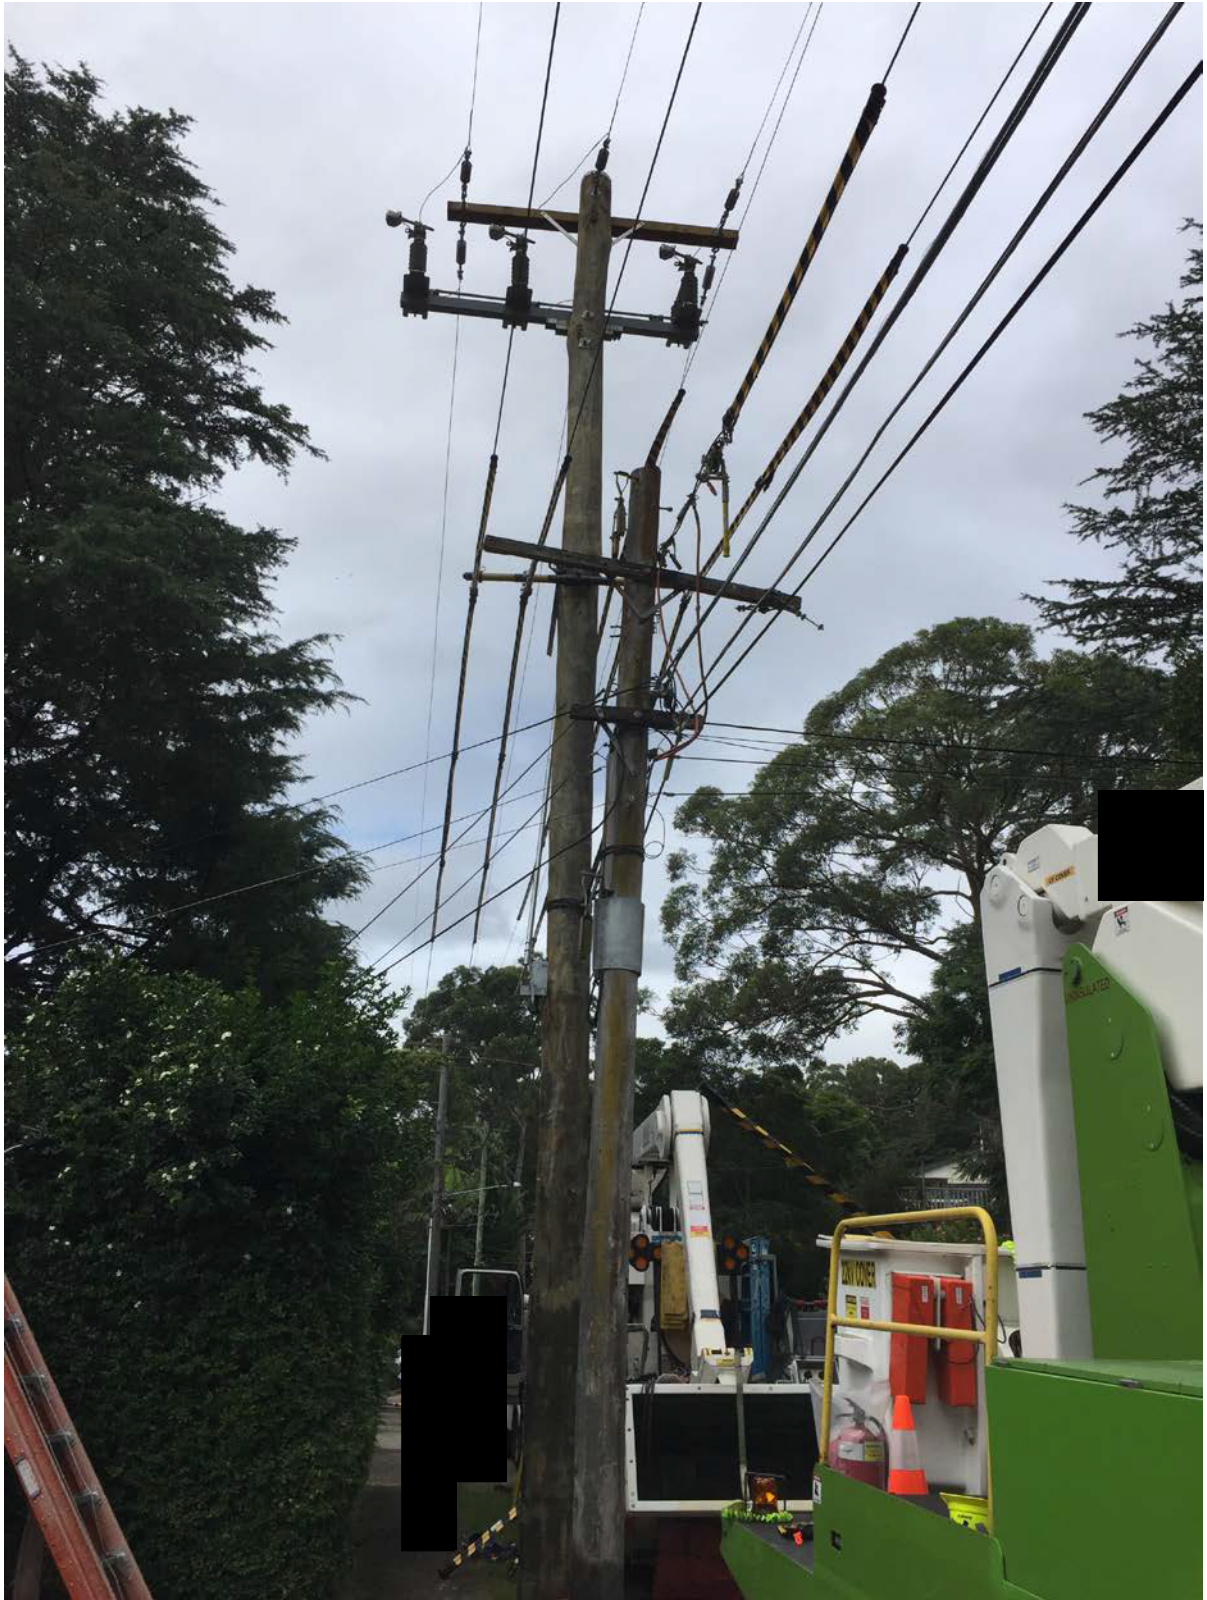
Images taken at site by an IPART inspector after the accident
