## Safety Alert 191209-1B (Update)

22 June 2020

### Serious burns sustained while operating high voltage oil-filled switchgear

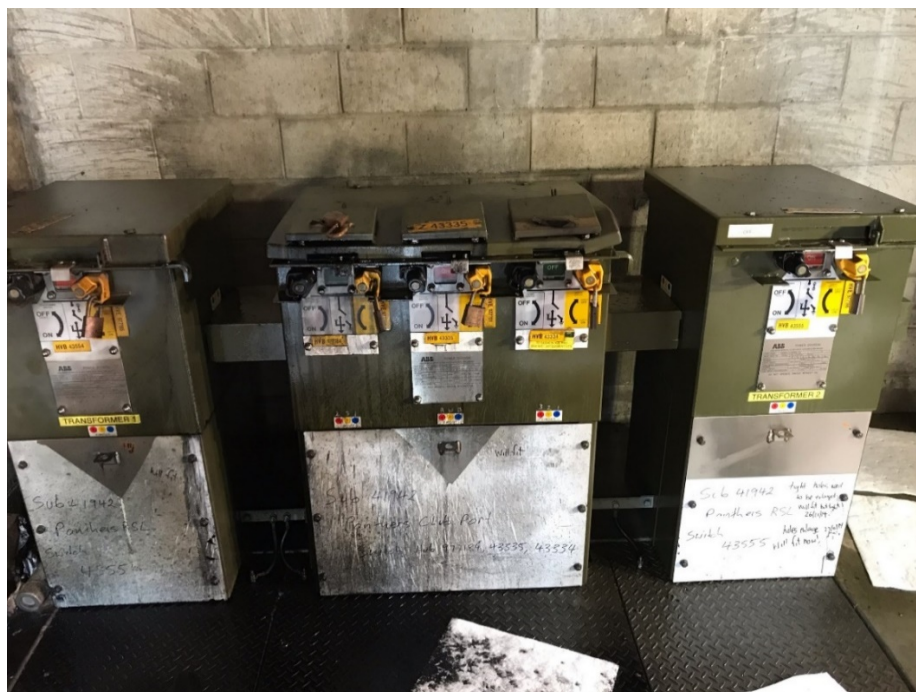
Image taken at site by a SafeWork NSW inspector after the accident

The Switch was found in the open position with evidence of arcing on the tips of both its moving and stationary contacts. The Switch was assessed and tested and found to be performing as designed. The physical evidence suggests that the field operator was in the process of an uninstructed open operation of the Switch as the CB closed.

This caused an electrical arc as a result of the Switch attempting to break fault current<sup>3</sup>. The pressure generated by the arc caused deformation of the switchgear lid and the ejection of hot oil over both employees.

- ▼ The auto reclose function must be disabled on the closest immediately upstream auto reclose device prior to carrying out field switching of any high voltage overhead or underground switch, except for:

- ▼ Anyone not directly involved with the switching operation or assisting/supervising the switching operator, must remain at a sufficient distance from the operating area to prevent risk exposure due to equipment failure or an arc flash. Any persons required to assist/supervise the switching operator must use the same PPE requirements as the switching operator.
