Richmond Ecohealth Project 2014

Assessment of River and Estuarine Condition

Final Technical Report

June 2015

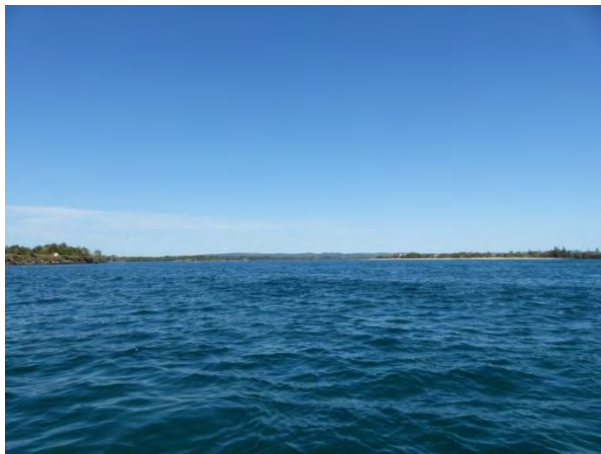
RR1 facing upstream: PCVS – Planform controlled, tidal.

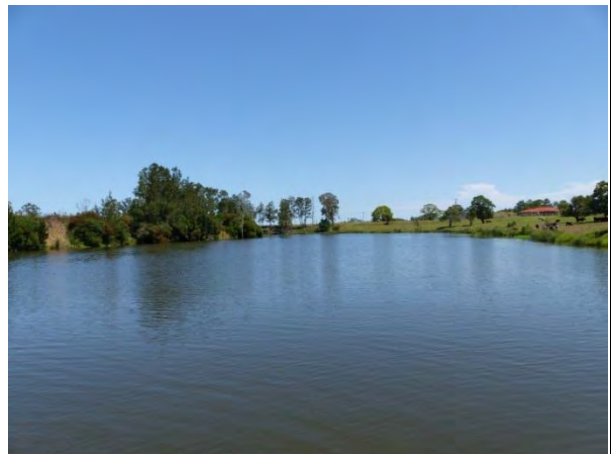
RR8 facing downstream: LUV CC – Meandering, fine grained.

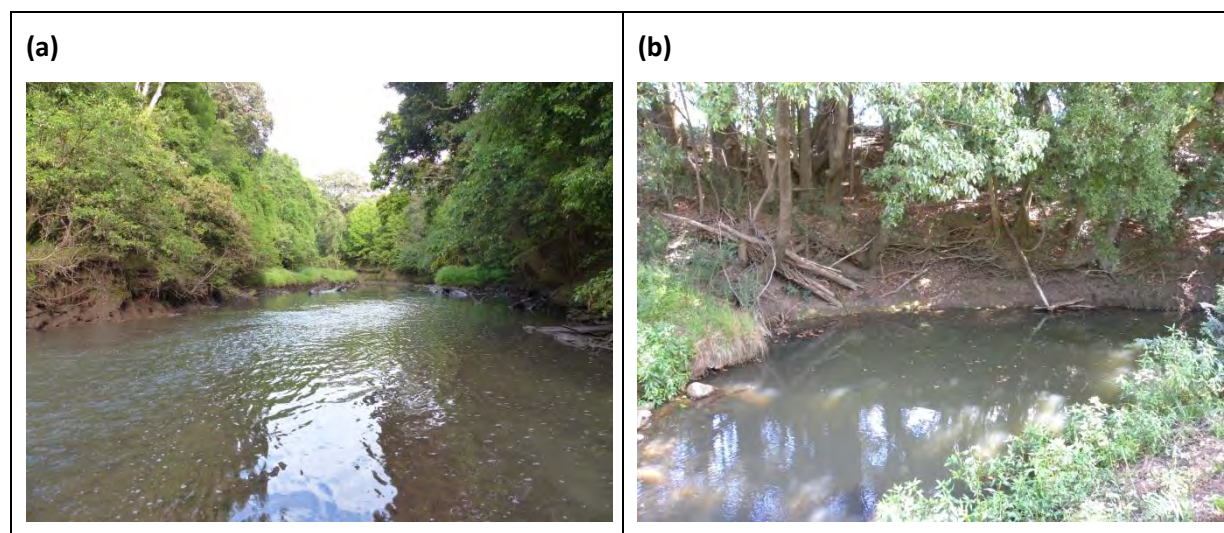
Figure 3.8 Sites in the Wilsons catchment showing (a) bank erosion and smothering of the streambed by fine-grained sediments (WR4), (b) poor bank condition at a heavily grazed site with sparse ground cover (BYC1).
