Mosman
COUNCIL

ASSET MANAGEMENT Marine Structures

1 Executive Summary

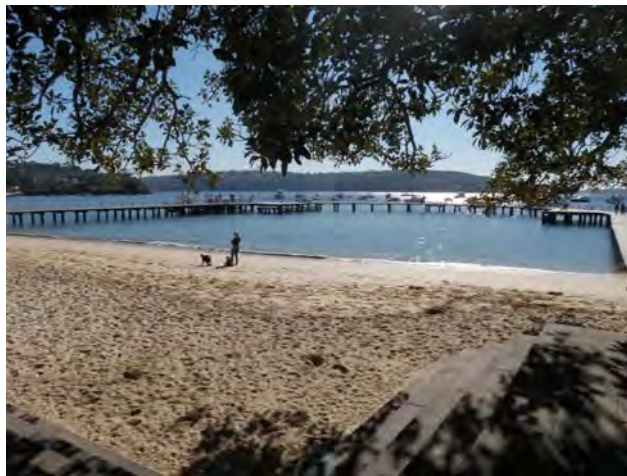
Figure 1: Balmoral Baths and Jetty

Main Structure Elements	Condition Grade	Comment
Timber handrails	2	Some minor corrosion to connections
Timber decking	2	Some loose coach screws
Timber headstocks	1-4	Some headstocks display advanced weathering and severely corroded bolted connections
Timber girders	2	Some weathering and corrosion to bolted connections
Timber piles	1-5	30 new piles, 142 piles with 15% section loss and 8 piles requiring replacement
Shark netting	2	Some large holes in net requiring repair

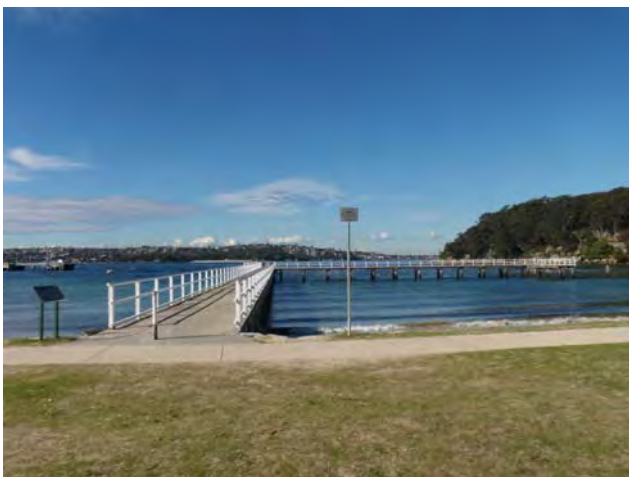
Figure 2: Clifton Gardens Baths and Jetty

Main Structure Elements	Condition Grade	Comment
Timber handrails	1	Freshly painted
Concrete decking	2	Some minor loss of concrete
Timber headstocks	2	Corroded bolted connections
Timber girders	1-5	14 new piles, 124 piles with 15% section loss and 7 piles requiring replacement
Shark netting	2	Some large holes in net requiring repair

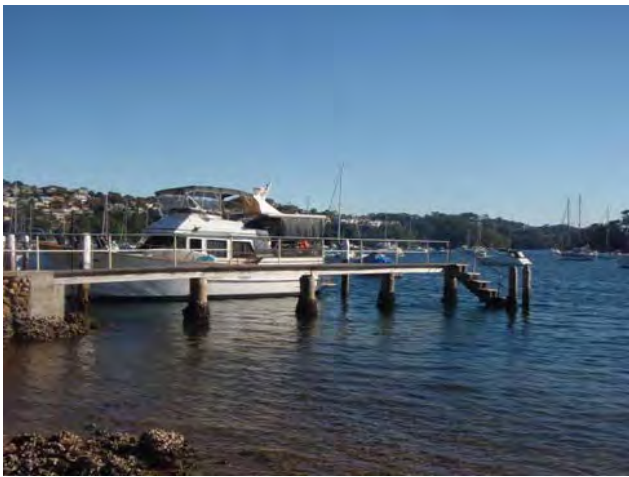
Figure 3: Inkerman Street Jetty

Main Structure Elements	Condition Grade	Comment
Steel handrails	2	Missing central railing
Timber decking	1	Very Good condition
Timber stairs	5	Complete loss of connection to supporting timber piles. Close jetty and repair.
Timber girders	2	Some timber distortion at connections
Piles	3 & 4	Main piles condition 3 due to sleeve cracking at the top of pile. 2 end of stair piles are condition 4 due to worm attack.

Main Structure Elements	Condition Grade	Comment
Adjacent sandstone wall and cause way	5	Stones supporting footpath are loose, and grout around stones is eroded throughout wall.

- Replacement of corroded steel connectors (Bolts, screws and splice plates etc)
- Replacement of piles with a section loss 50% or greater.
- Replacement of timber stairs on the Inkerman Street jetty (severely deteriorated).
- Replace signage when out dated

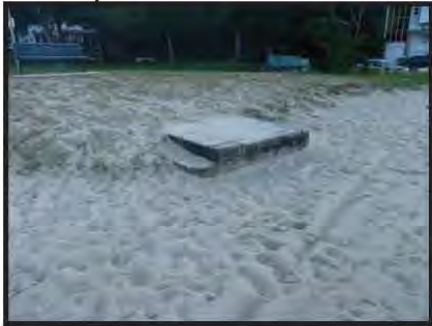
Sandstone steps. Condition 1.

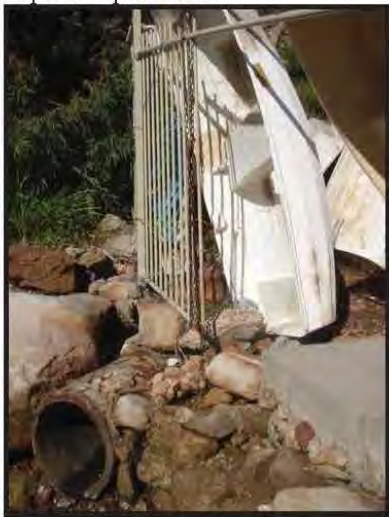
450mm stormwater pipe outlet at the eastern end of site.

Note: The neighbouring fence (not a council asset) on the eastern end of site has severe corrosion and requires replacement

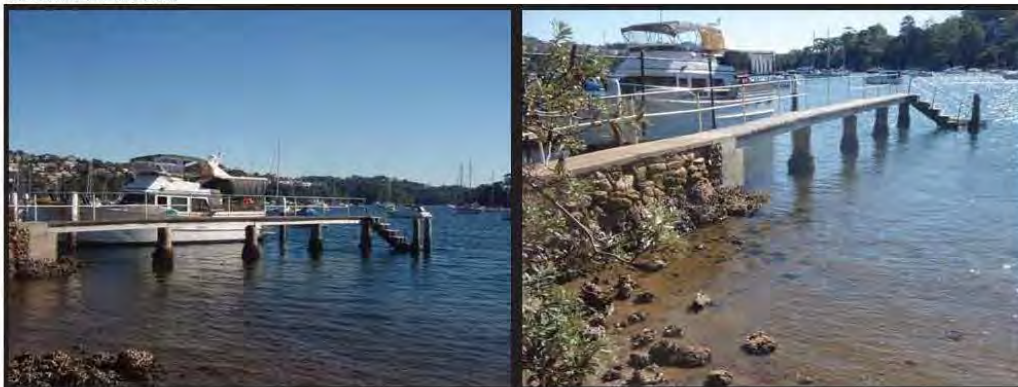
General Photos.

Structure Elements - IS1		
Element 1 – Seawall adjacent to jetty including jetty causeway.		
Element Material	Sandstone	
Element Dimensions	0.9 – 1.1m high	Condition Category: 5 – Repair required
<p>Element Description: Sandstone mass wall, including protrusions of natural sandstone bed rock. Stones loose and grout around stones eroded away throughout wall. Replace and inject grout between stones in seawall. Add riprap at 3:1 grade in front of seawall as specified in Brown drawing X04492-S02 attached.</p>

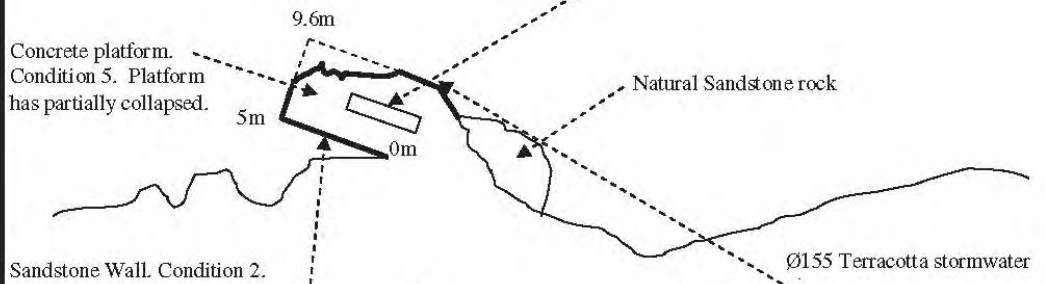
Collapsed seawall. Condon 5.
Repair seawall.

Park bench. 1 missing back plank. Replace.
Condition 4.
