NORTH SYDNEY COUNCIL

ASSET MANAGEMENT PLAN

ROADS ASSET CLASS

2025/35

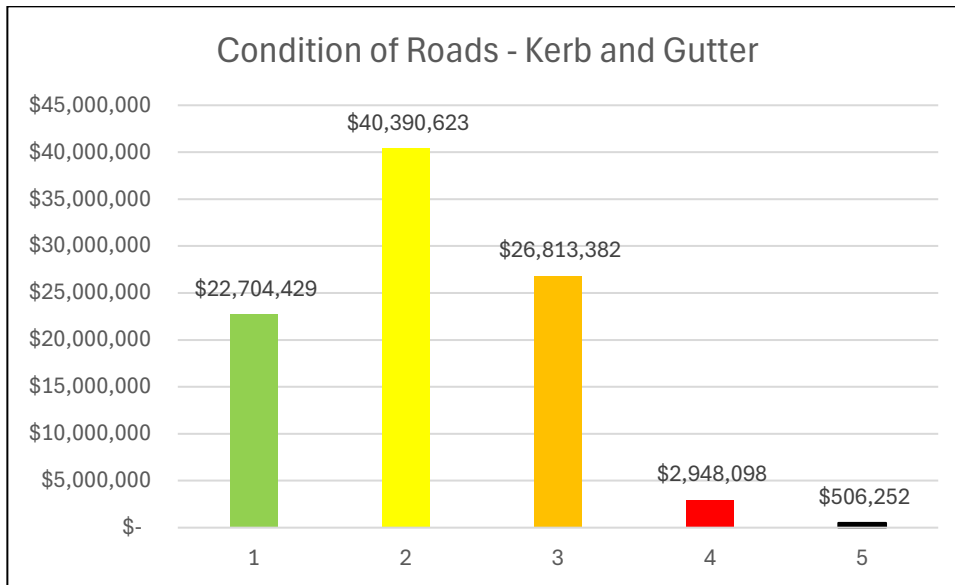
The Graph below shows the condition of Kerb and Gutter assets in terms of replacement cost.

Condition	Replacement Cost (2024)	% Condition (based on cost)
1 (Very Good)	\$22,704,429	24.3%
2 (Good)	\$40,390,623	43.3%
3 (Fair)	\$26,813,382	28.7%
4 (poor)	\$2,948,098	3.2%
5 (Very Poor)	\$506,252	0.5%
Total	\$93,362,784	100.0%

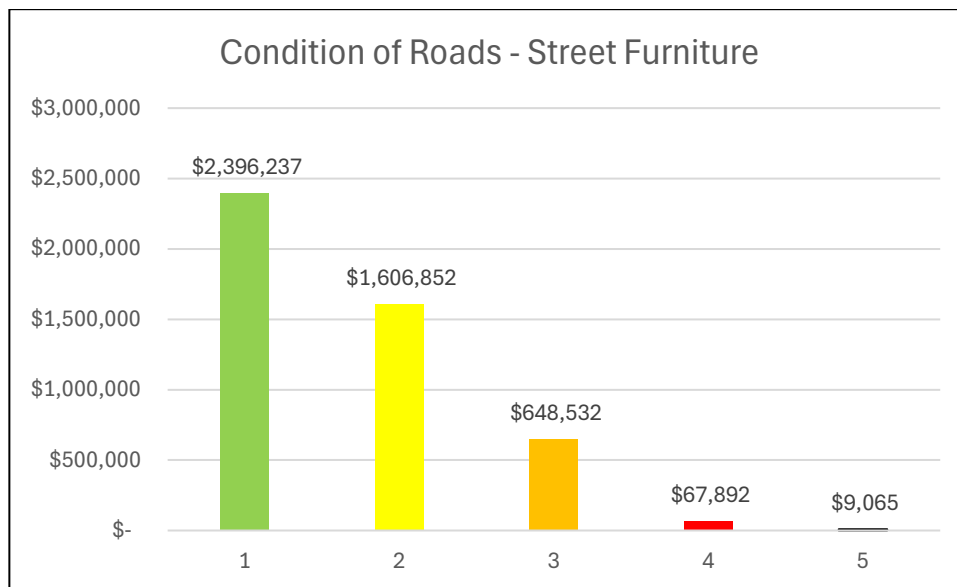
The Graph below shows the condition of Street Furniture assets in terms of replacement cost.

Condition	Replacement Cost (2024)	% Condition (based on cost)
1 (Very Good)	\$2,396,237	50.7%
2 (Good)	\$1,606,852	34.0%
3 (Fair)	\$648,532	13.7%
4 (poor)	\$67,892	1.4%
5 (Very Poor)	\$9,065	0.2%
Total	\$4,728,578	100.0%

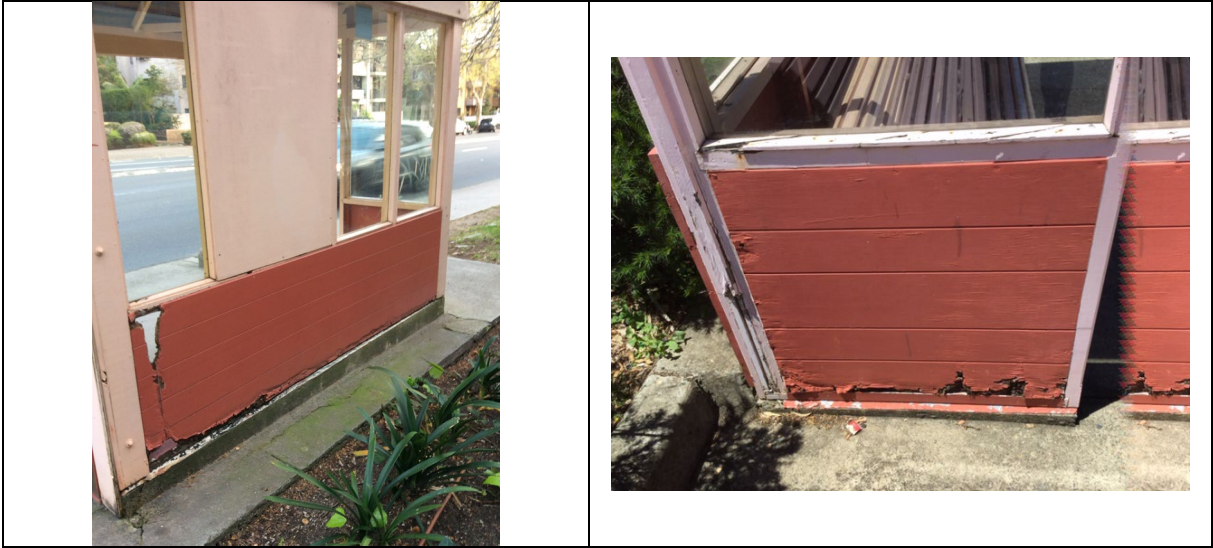
6.1 Examples of Bus shelter risks in the North Sydney LGA.

Examples of failed and failing Bus Shelters in the North Sydney LGA

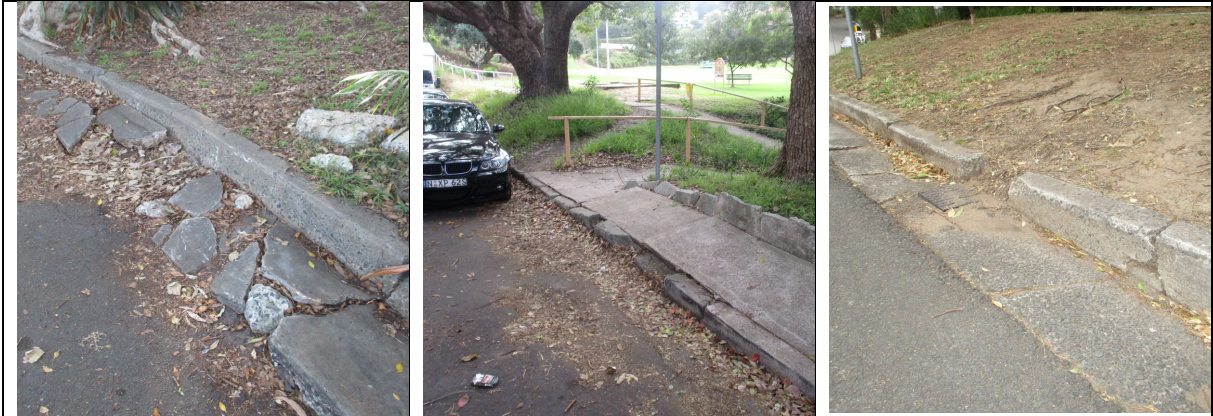
6.2 Examples of Kerb and Gutter risks in the North Sydney LGA.

Examples of failed and failing Kerb and Gutter in the North Sydney LGA

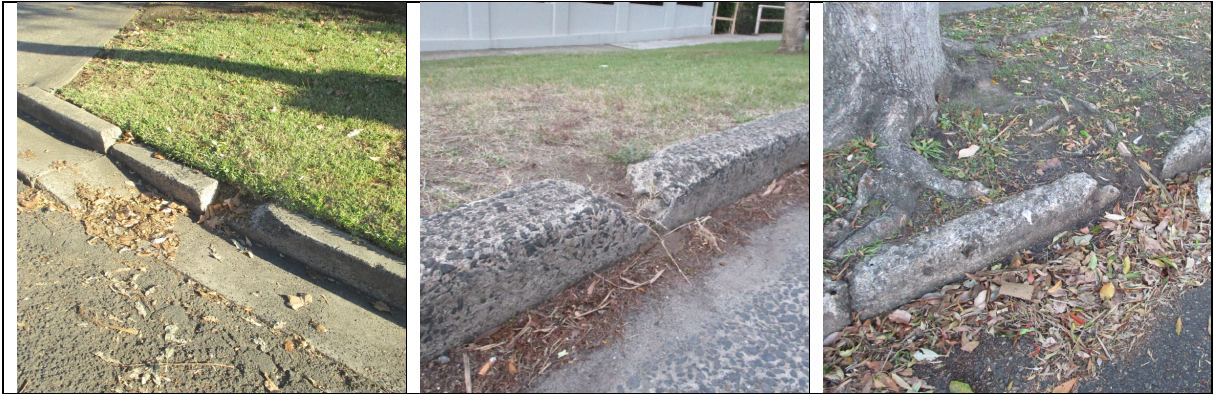
Examples of failed and failing Kerb and Gutter in the North Sydney LGA

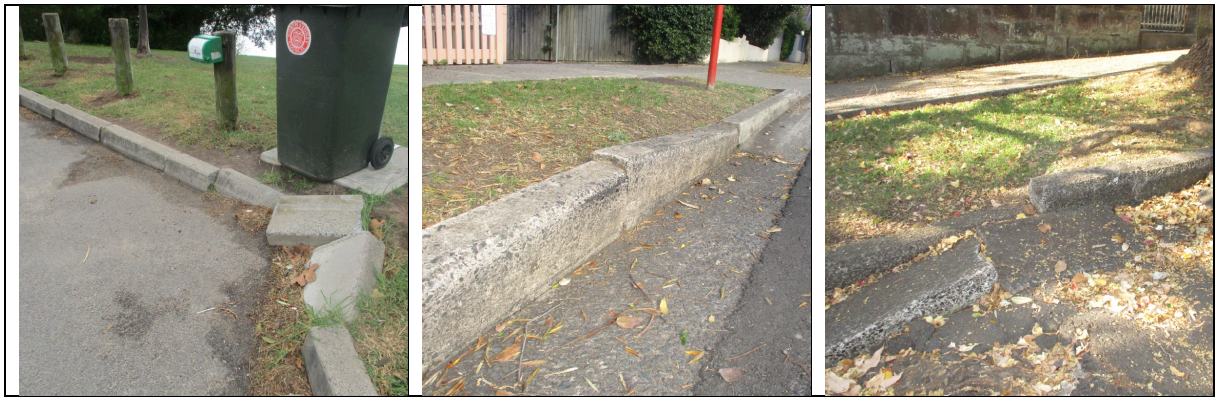
Examples of failed and failing Kerb and Gutter in the North Sydney LGA

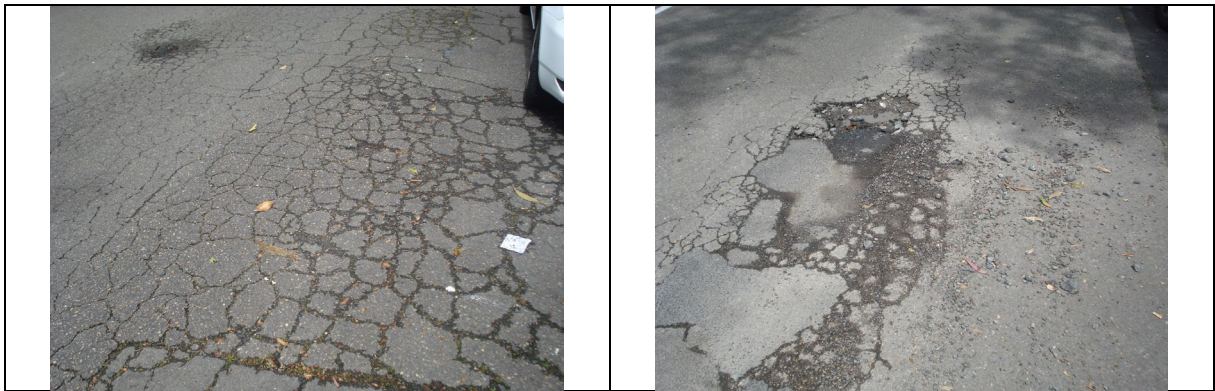
6.3 Examples of Road Pavement risks in the North Sydney LGA.

Examples of road pavements in poor condition in the North Sydney LGA

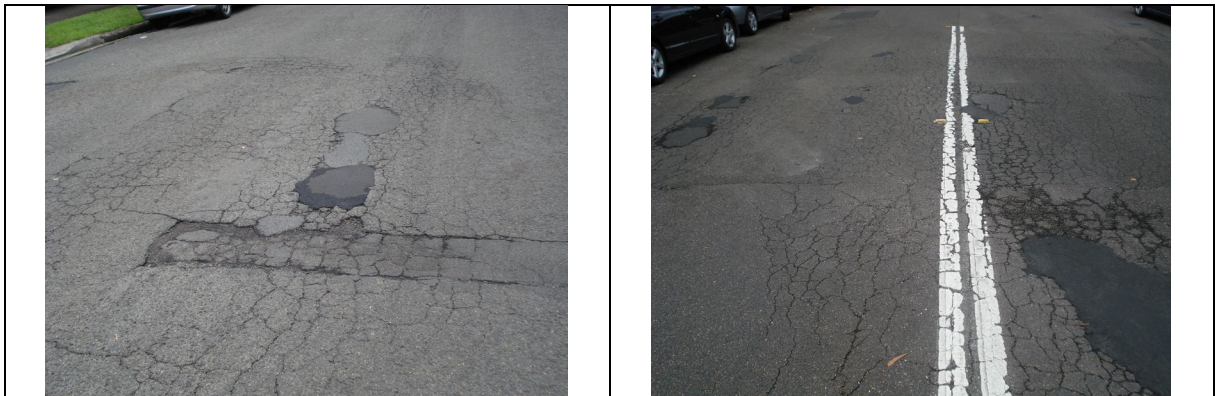
Examples of road pavements in poor condition in the North Sydney LGA

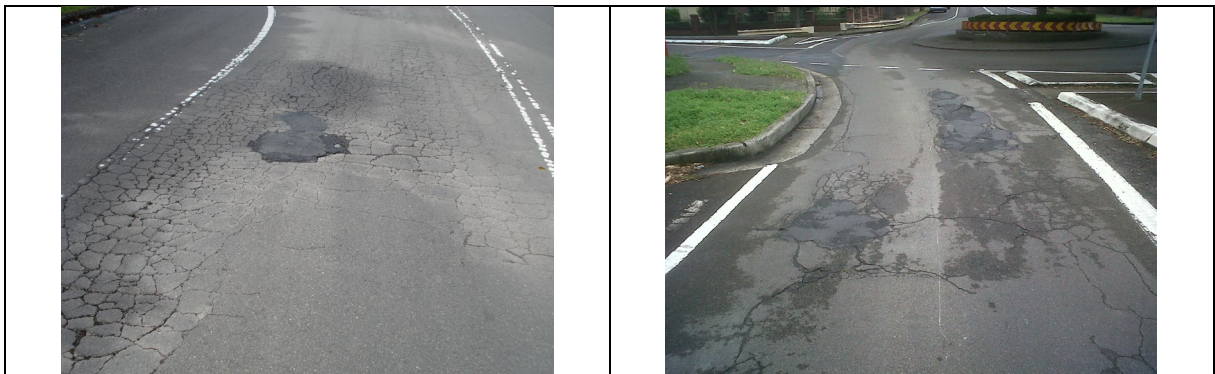
Examples of road pavements in poor condition in the North Sydney LGA

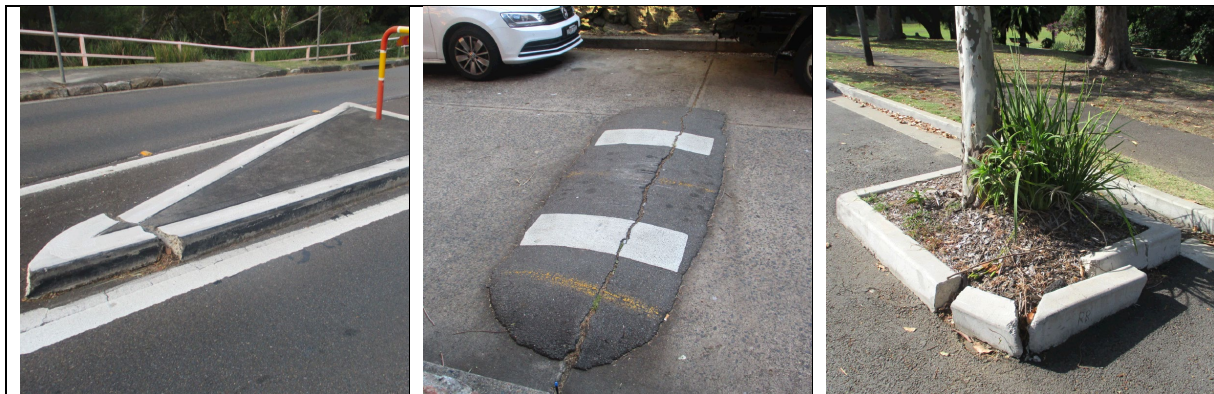
6.5 Examples of Traffic Facilities risks in the North Sydney LGA.

Examples of failed and failing Traffic Facilities in the North Sydney LGA

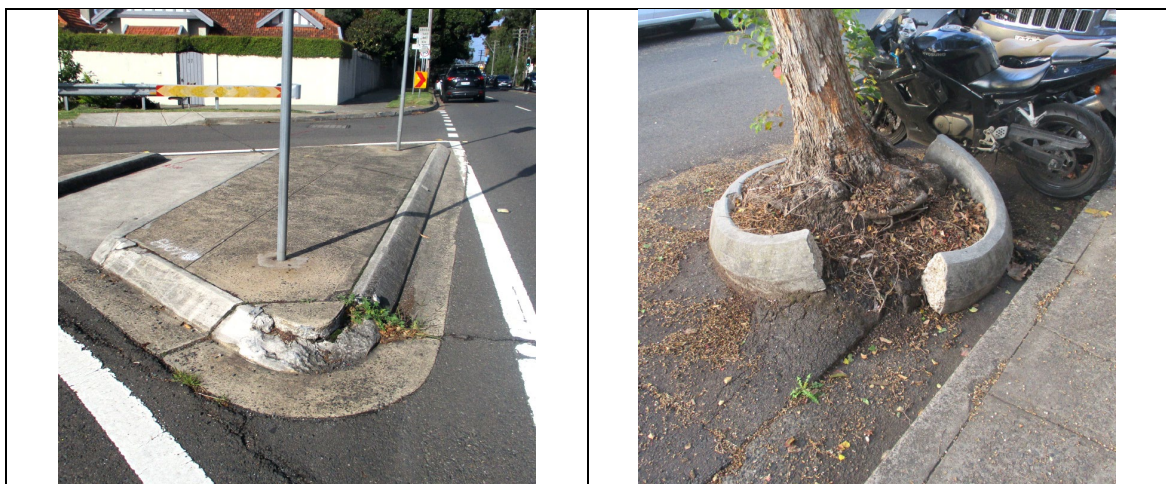
Examples of failed and failing Traffic Facilities in the North Sydney LGA

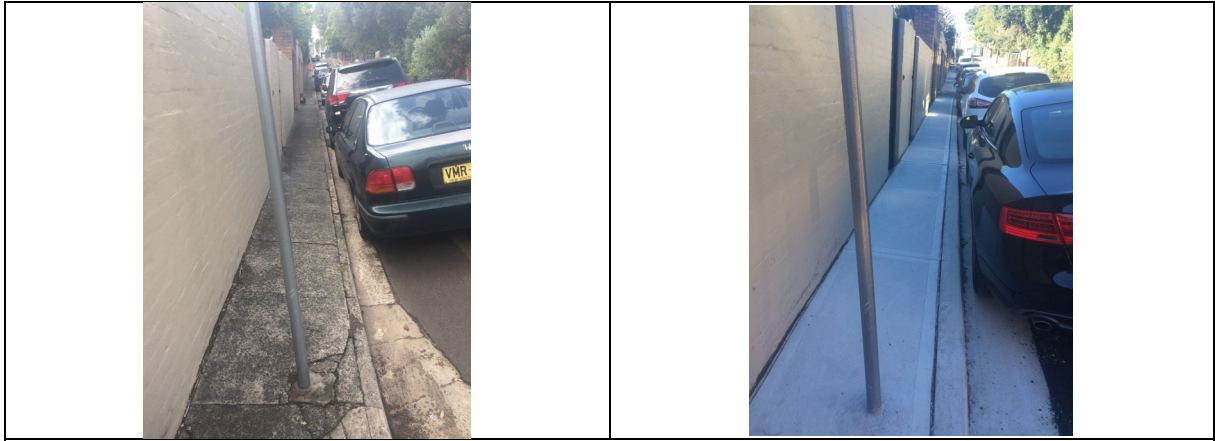
Kerb and Gutter, Crescent Place, Kirribilli – Before and After

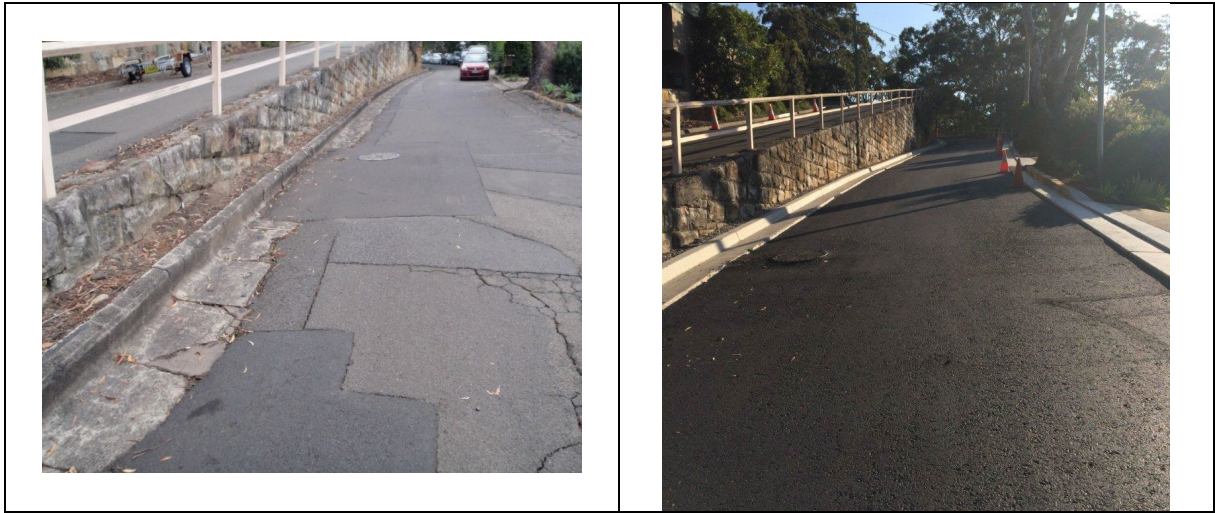
Road Pavement - Folly Point, Cammeray, before and after

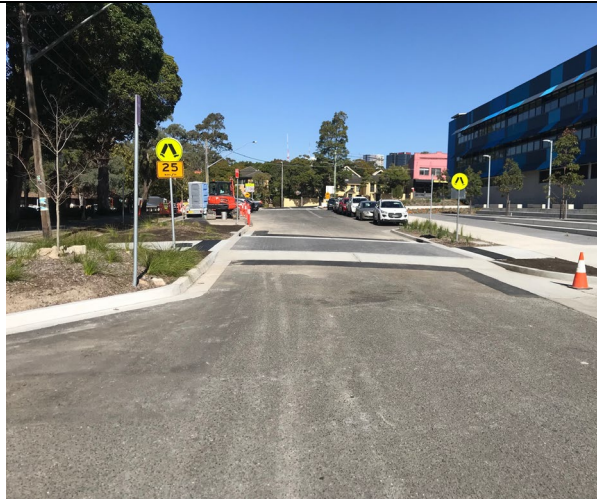
Traffic Facilities - Pedestrian Crossing – Anzac Avenue, Cammeray

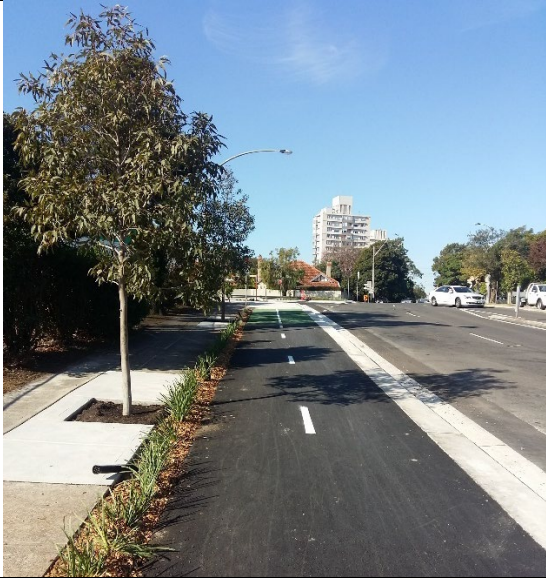
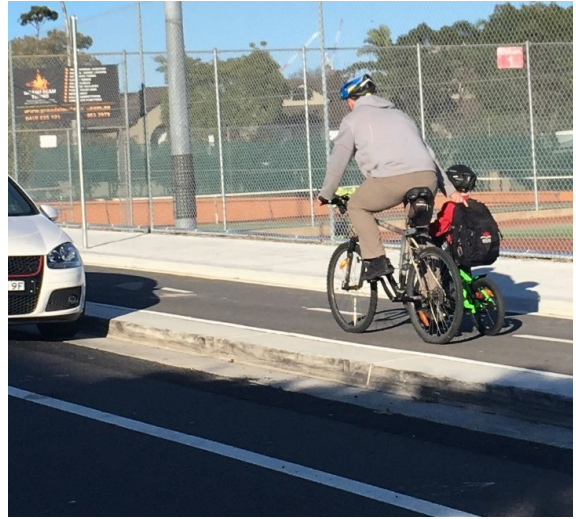
Traffic Facilities - Bi-directional separated cycle path on Ernest Street/Park Avenue
